HAND-OVER BOOK

S3

Sustainable Space Solutions B.V.

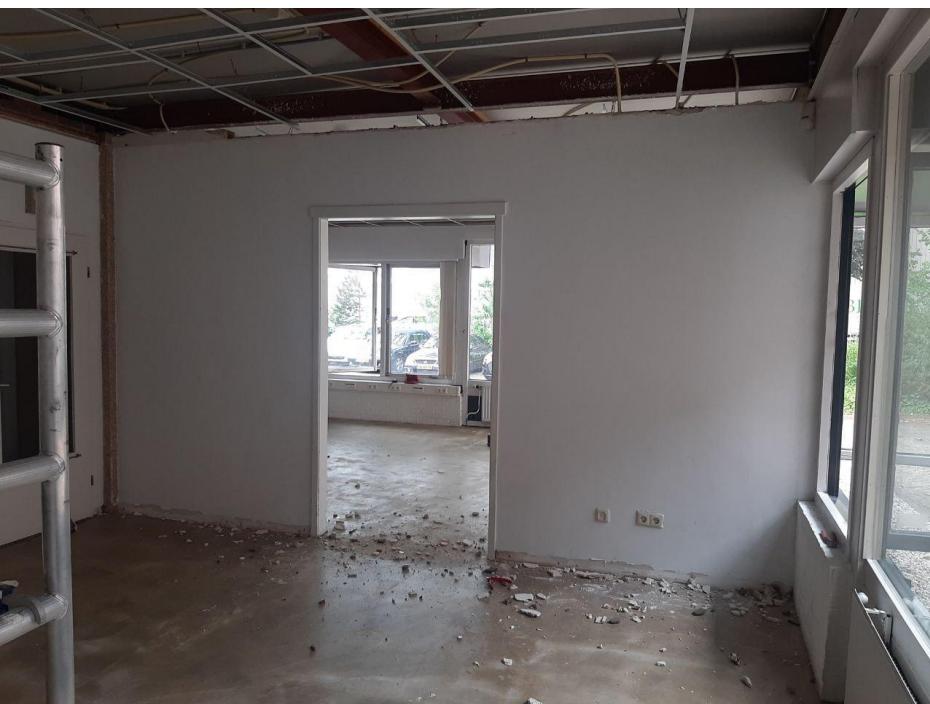
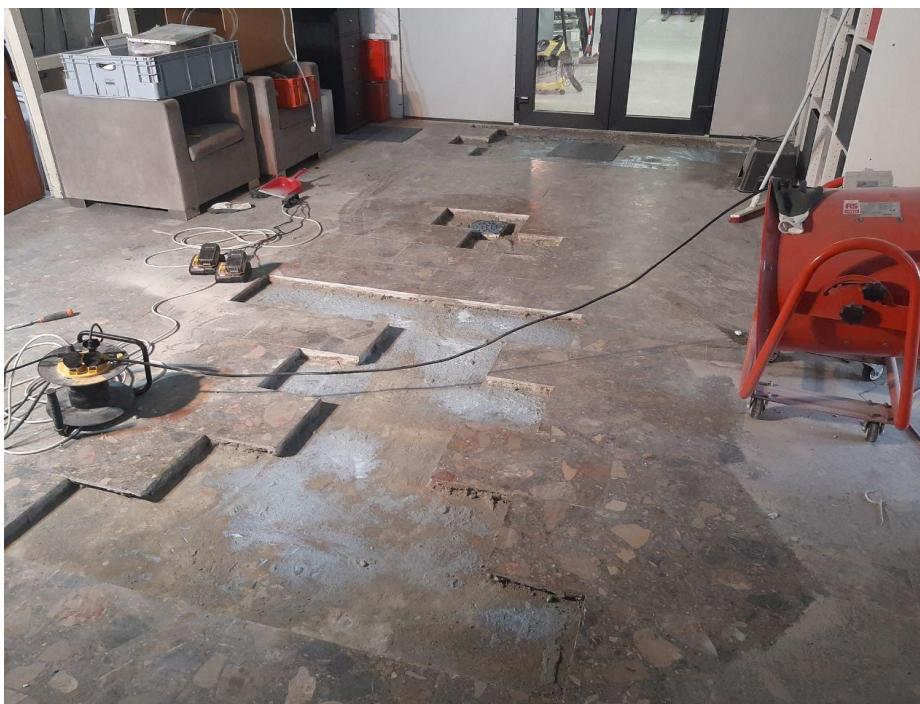
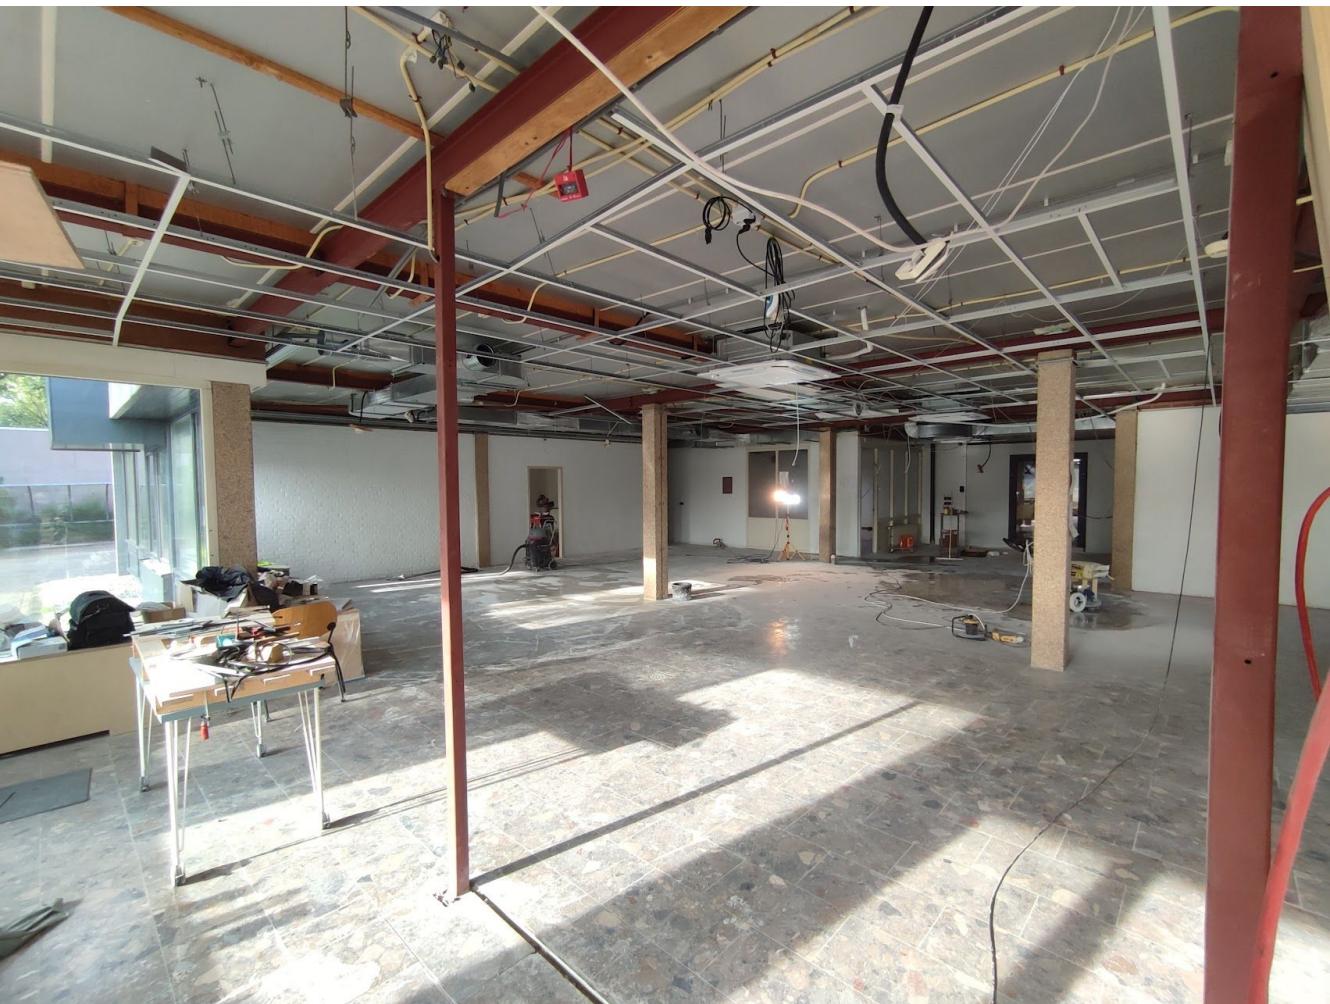
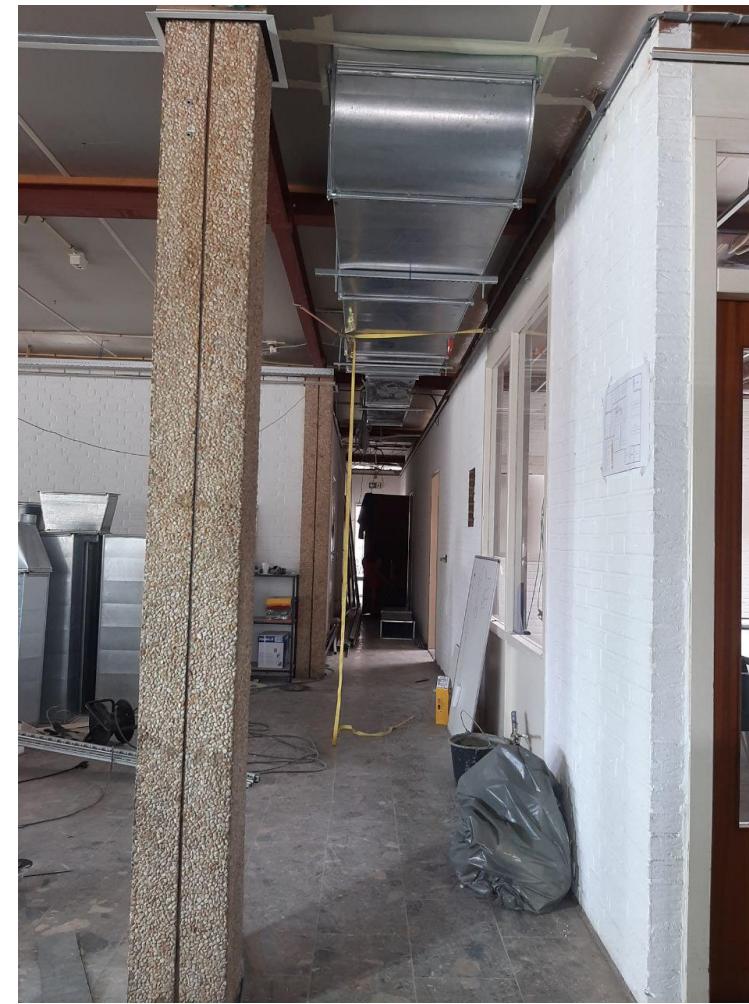
- Demontage inner works
- Demontage & reassembling of ceilings 884m² office part and BB parts
- Demontage of two windows and the bottom part of the facade in the new entrance zone 45,7 m²
- Replacing broken ceiling panels (office part)
- Restoration of most damaged stone tiles in the office part

An external company (Detect Milieu Services B.V.) has made an asbestos report:
CEAD confidential

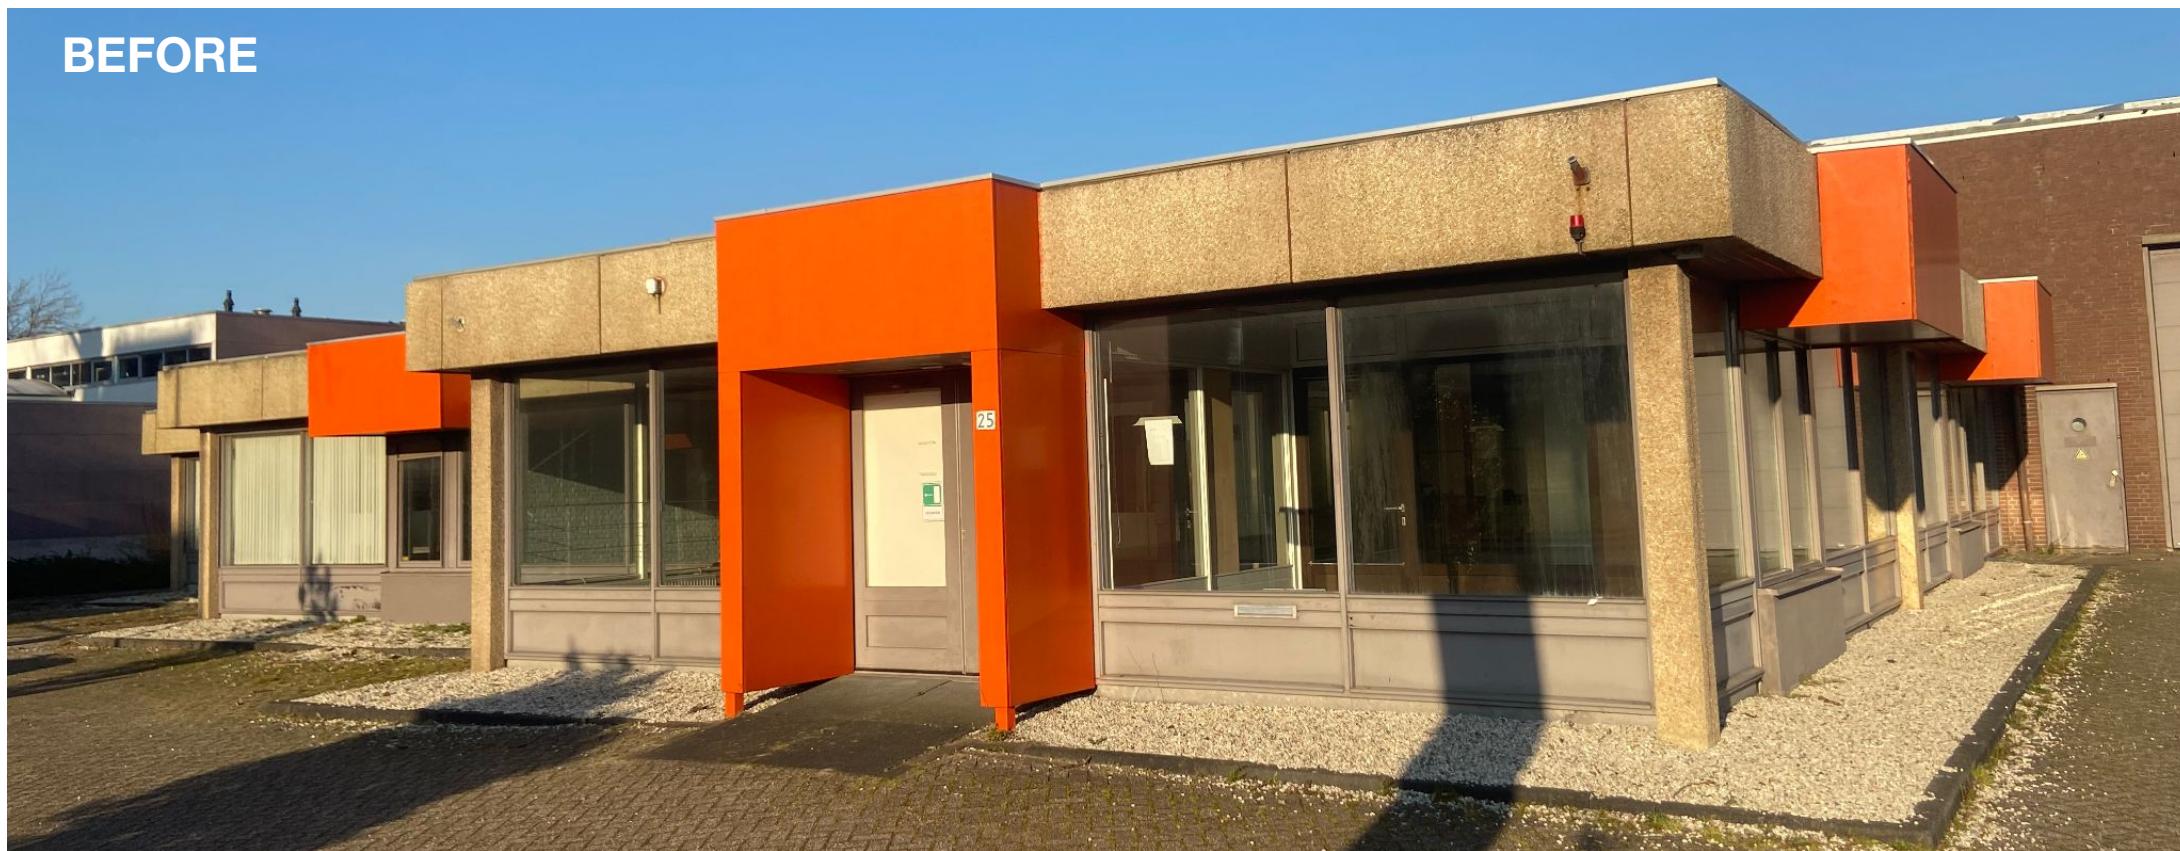
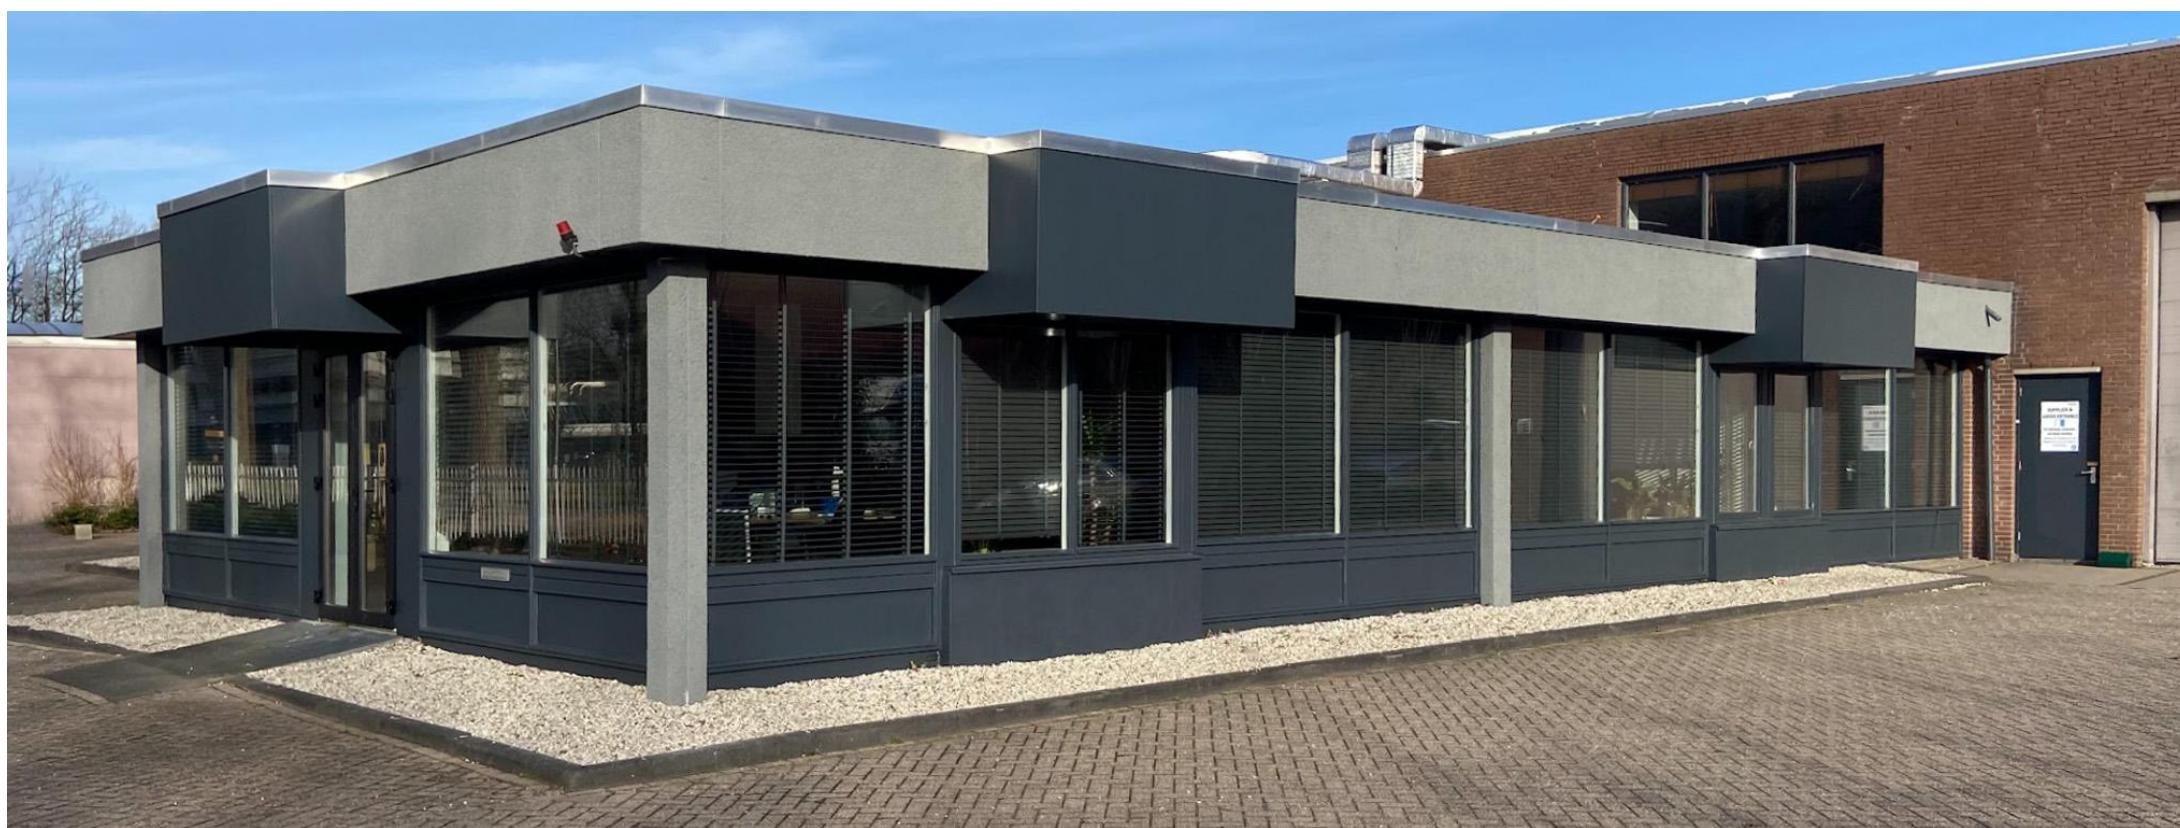
BEFORE

- Removing old paint from frames inside and out 284 m1.
- Sanding of wooden parts 31m2.
- Glass packaging (masking tape+plastic) 118 m2
- Sealing glazing beads with acrylic sealant 284 m1.
- Painting of wooden parts with acrylic paint 284 m1 + 160m2.
- Quartzprimer for stone parts.
- Primer for wooden parts.
- Painting stone parts with silicone paint Materials
- RAL 7016

Painted parts of the facade require renewal if imperfection and damages become visible after the warranty period to protect the base material and extend the lifetime of whole facade.

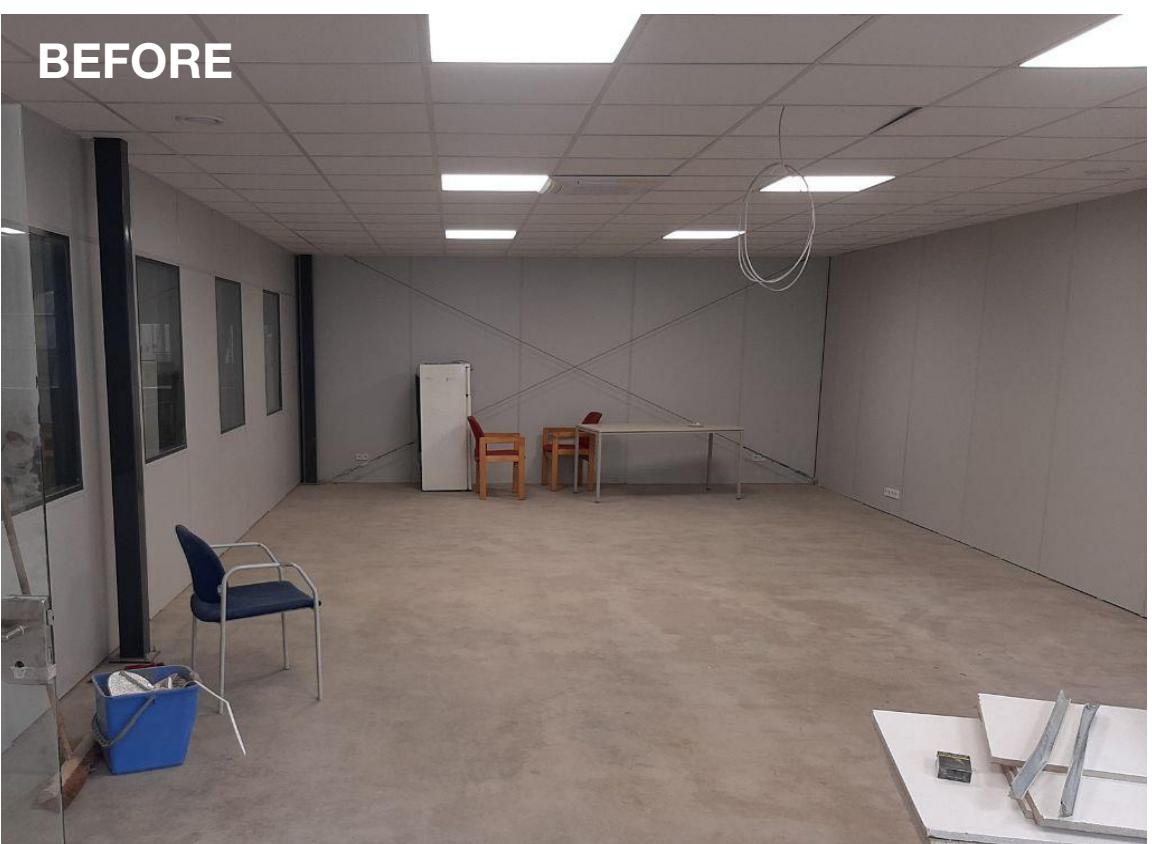
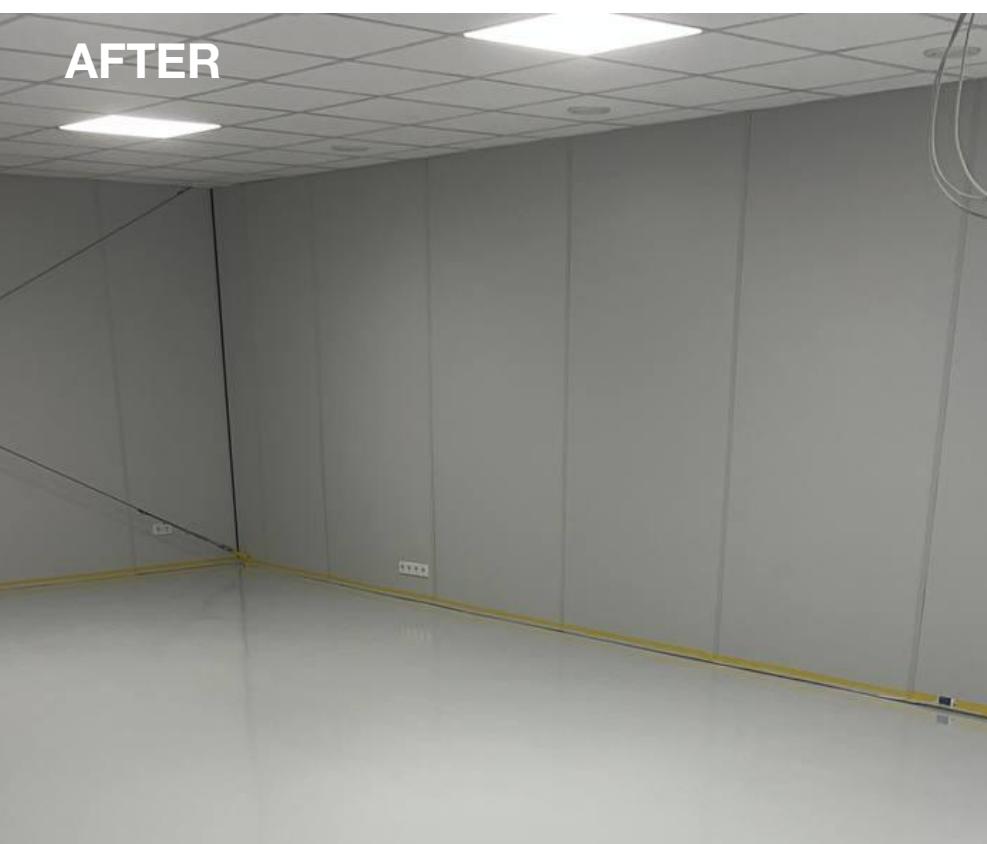
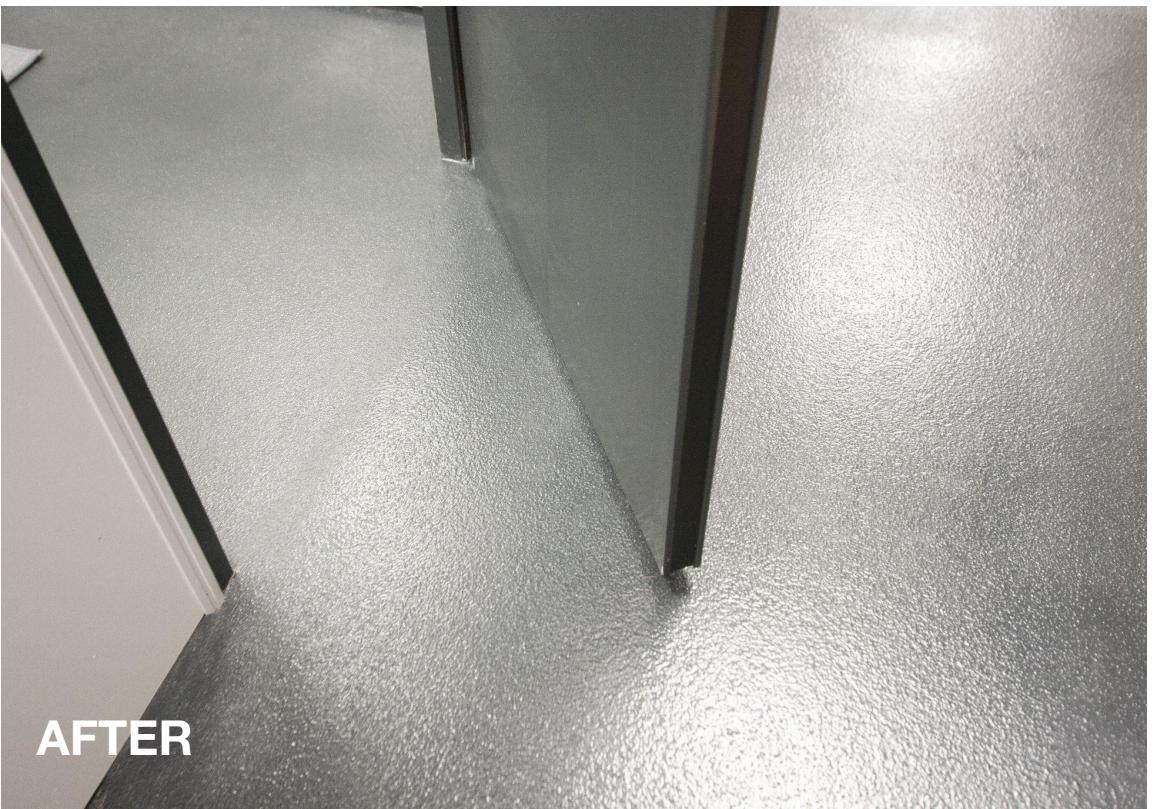
Painting of the floors with 2 component floor paint in toilet & shower zone and the floor of the Teamhonk. 138 sq m of floor paint incl. 35sq paint with additional sand

Toilet & showers RAL 7016
Teamhonk RAL 7040

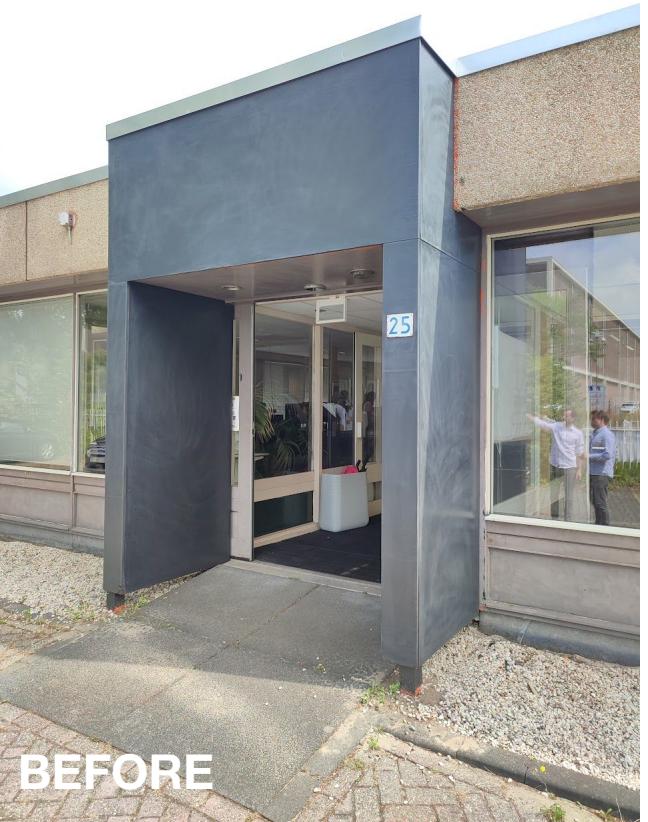
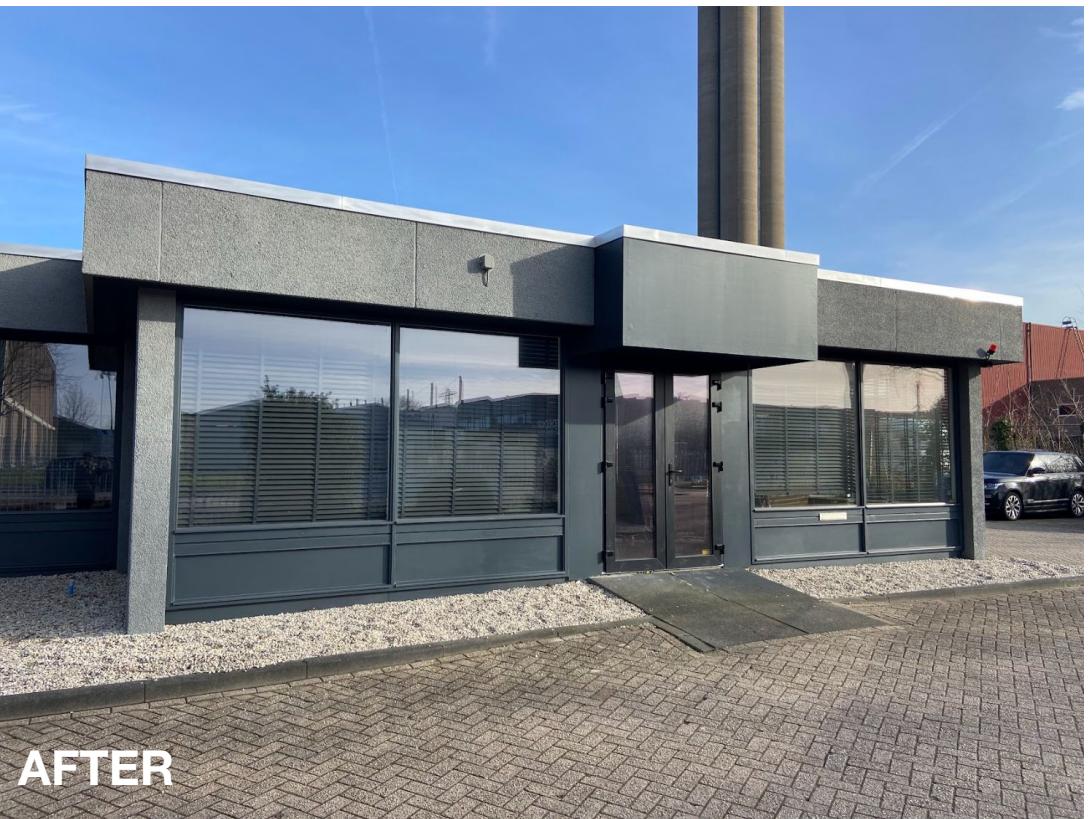
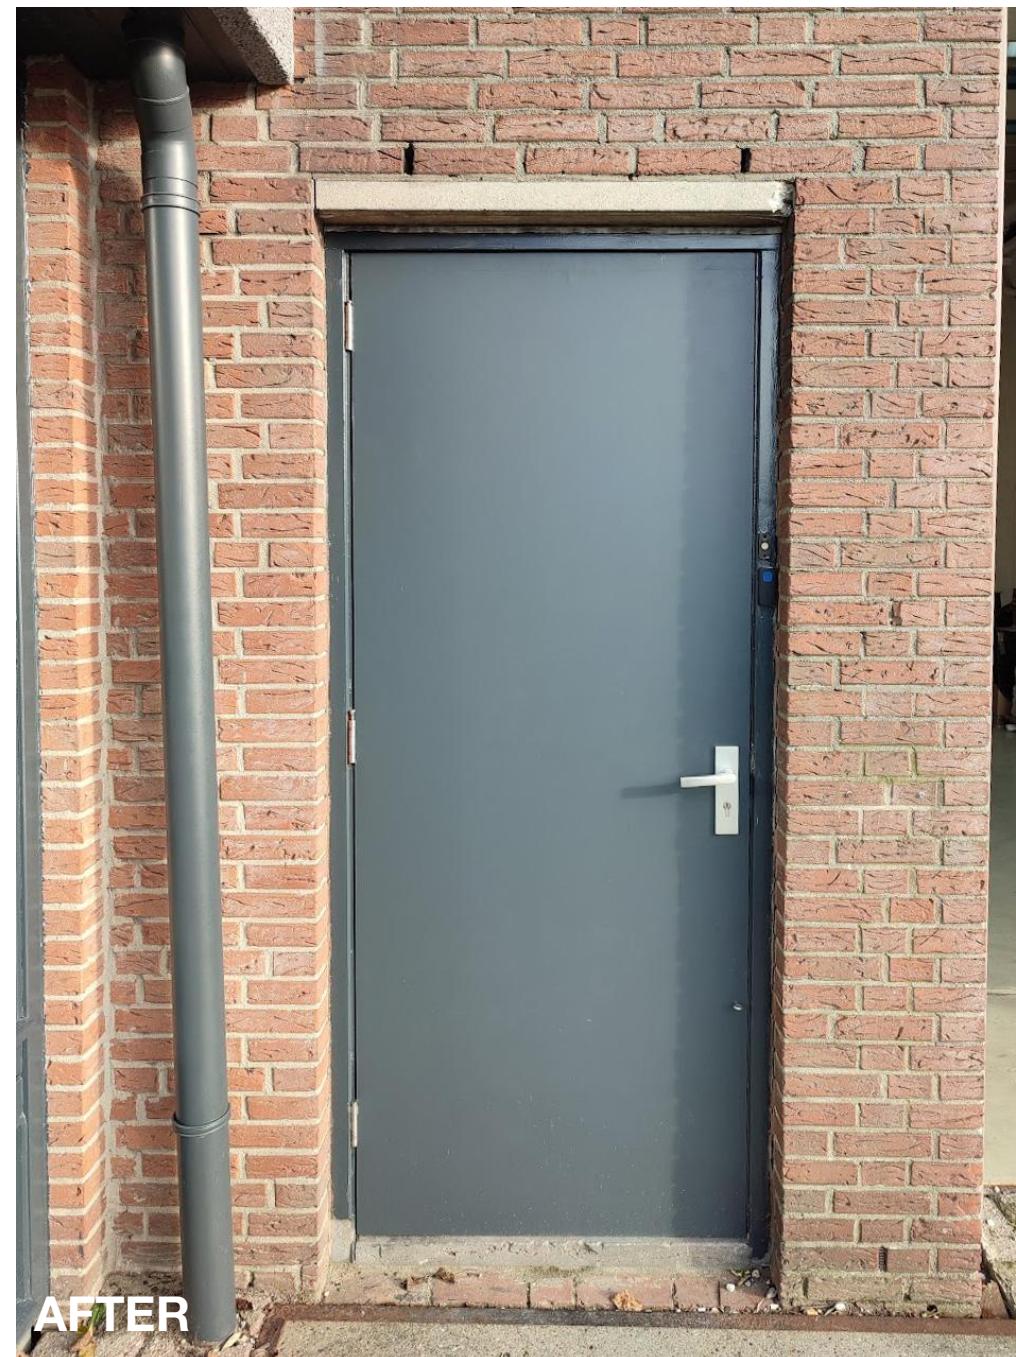
Demolishing of the old entrance door and replaced it with uPVC double door. Prepared and produced new door panel (supplier door) Installed new hinges. Primered + painted supplier door. Installation of the door handles etc. together with lock supplier.

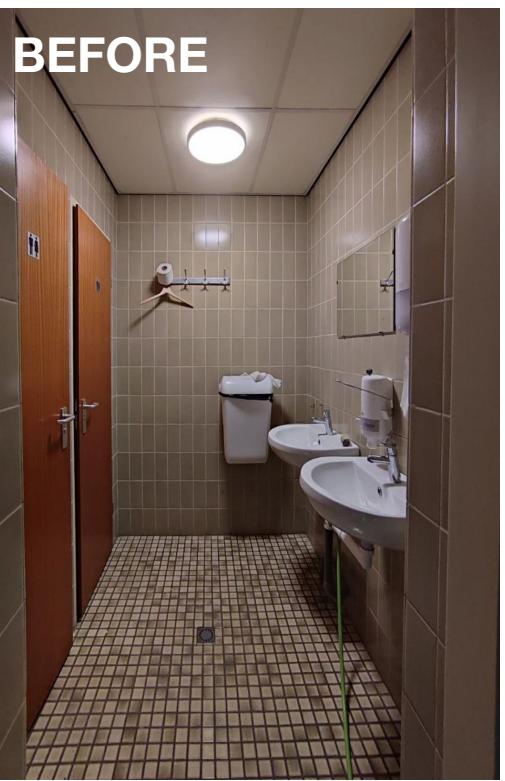
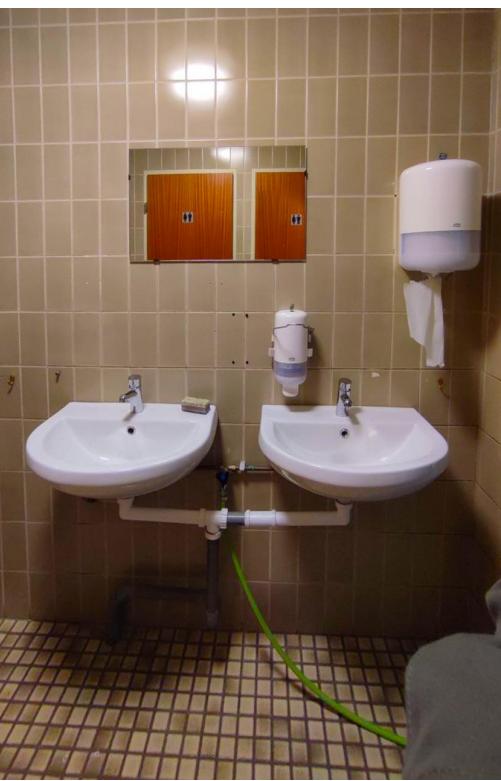
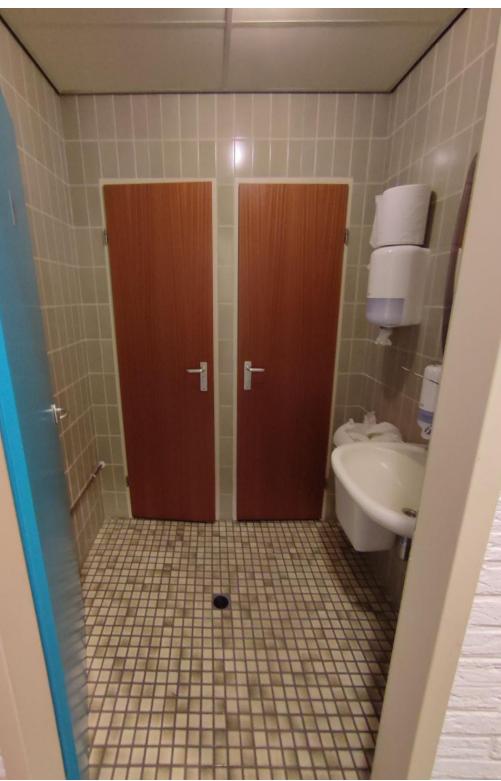
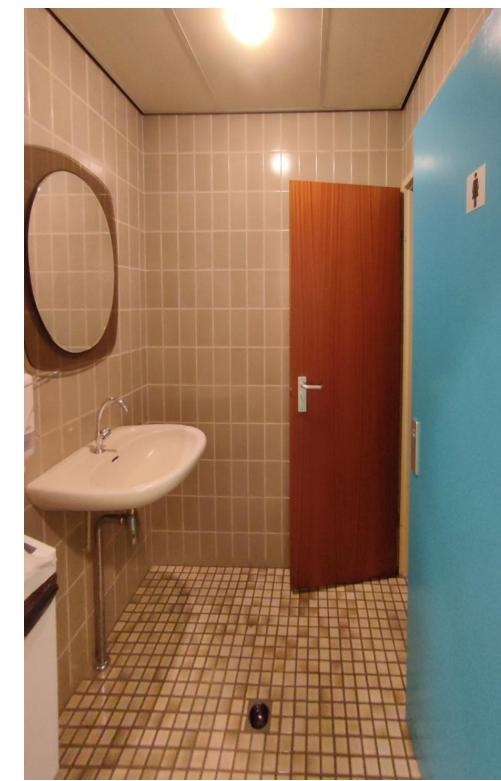
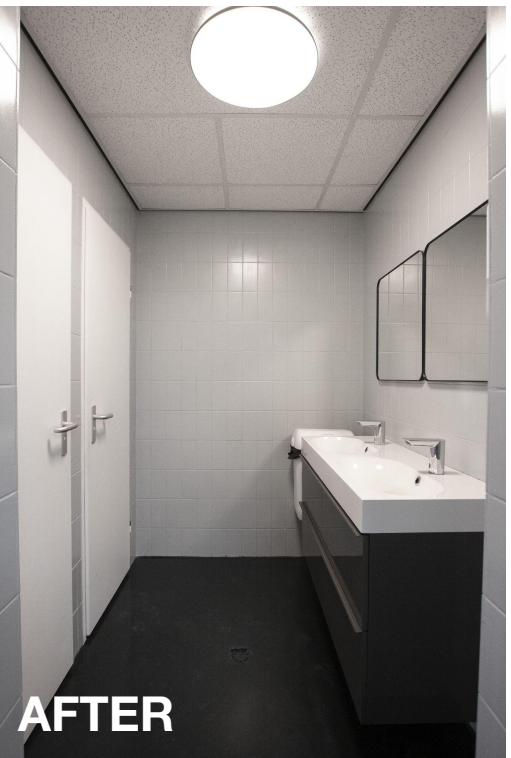
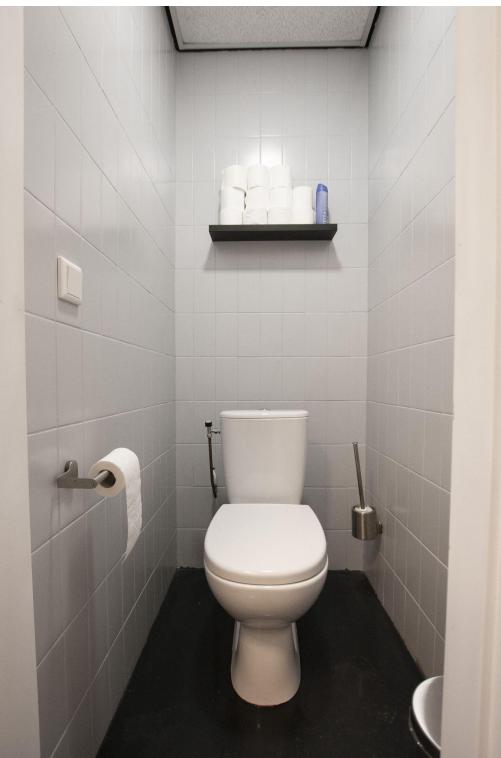
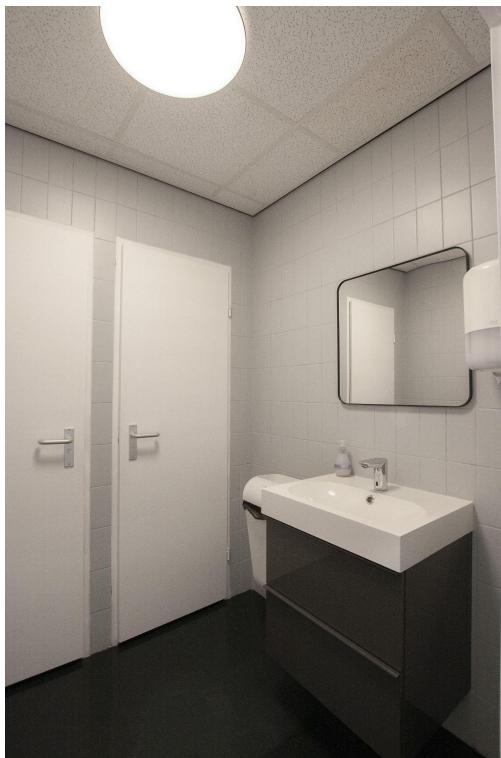
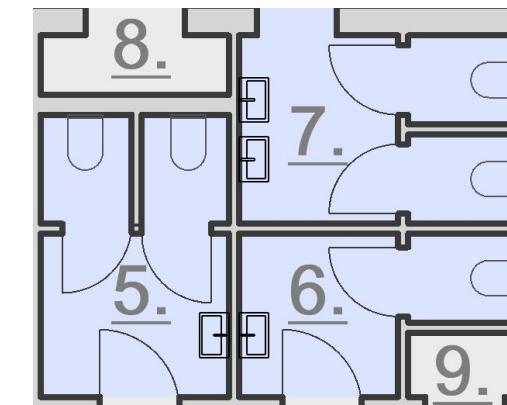
Making some basic refurbishment. Replaced: 4 sinks (countertop sinks) + 4 taps (sink mounted) 5 toilets (floor mounted) 1 sink drawer for 2 sinks 2 sink drawers for 1 sink Ceiling change 15 sq m Tile wall+floor painting 82 sq m

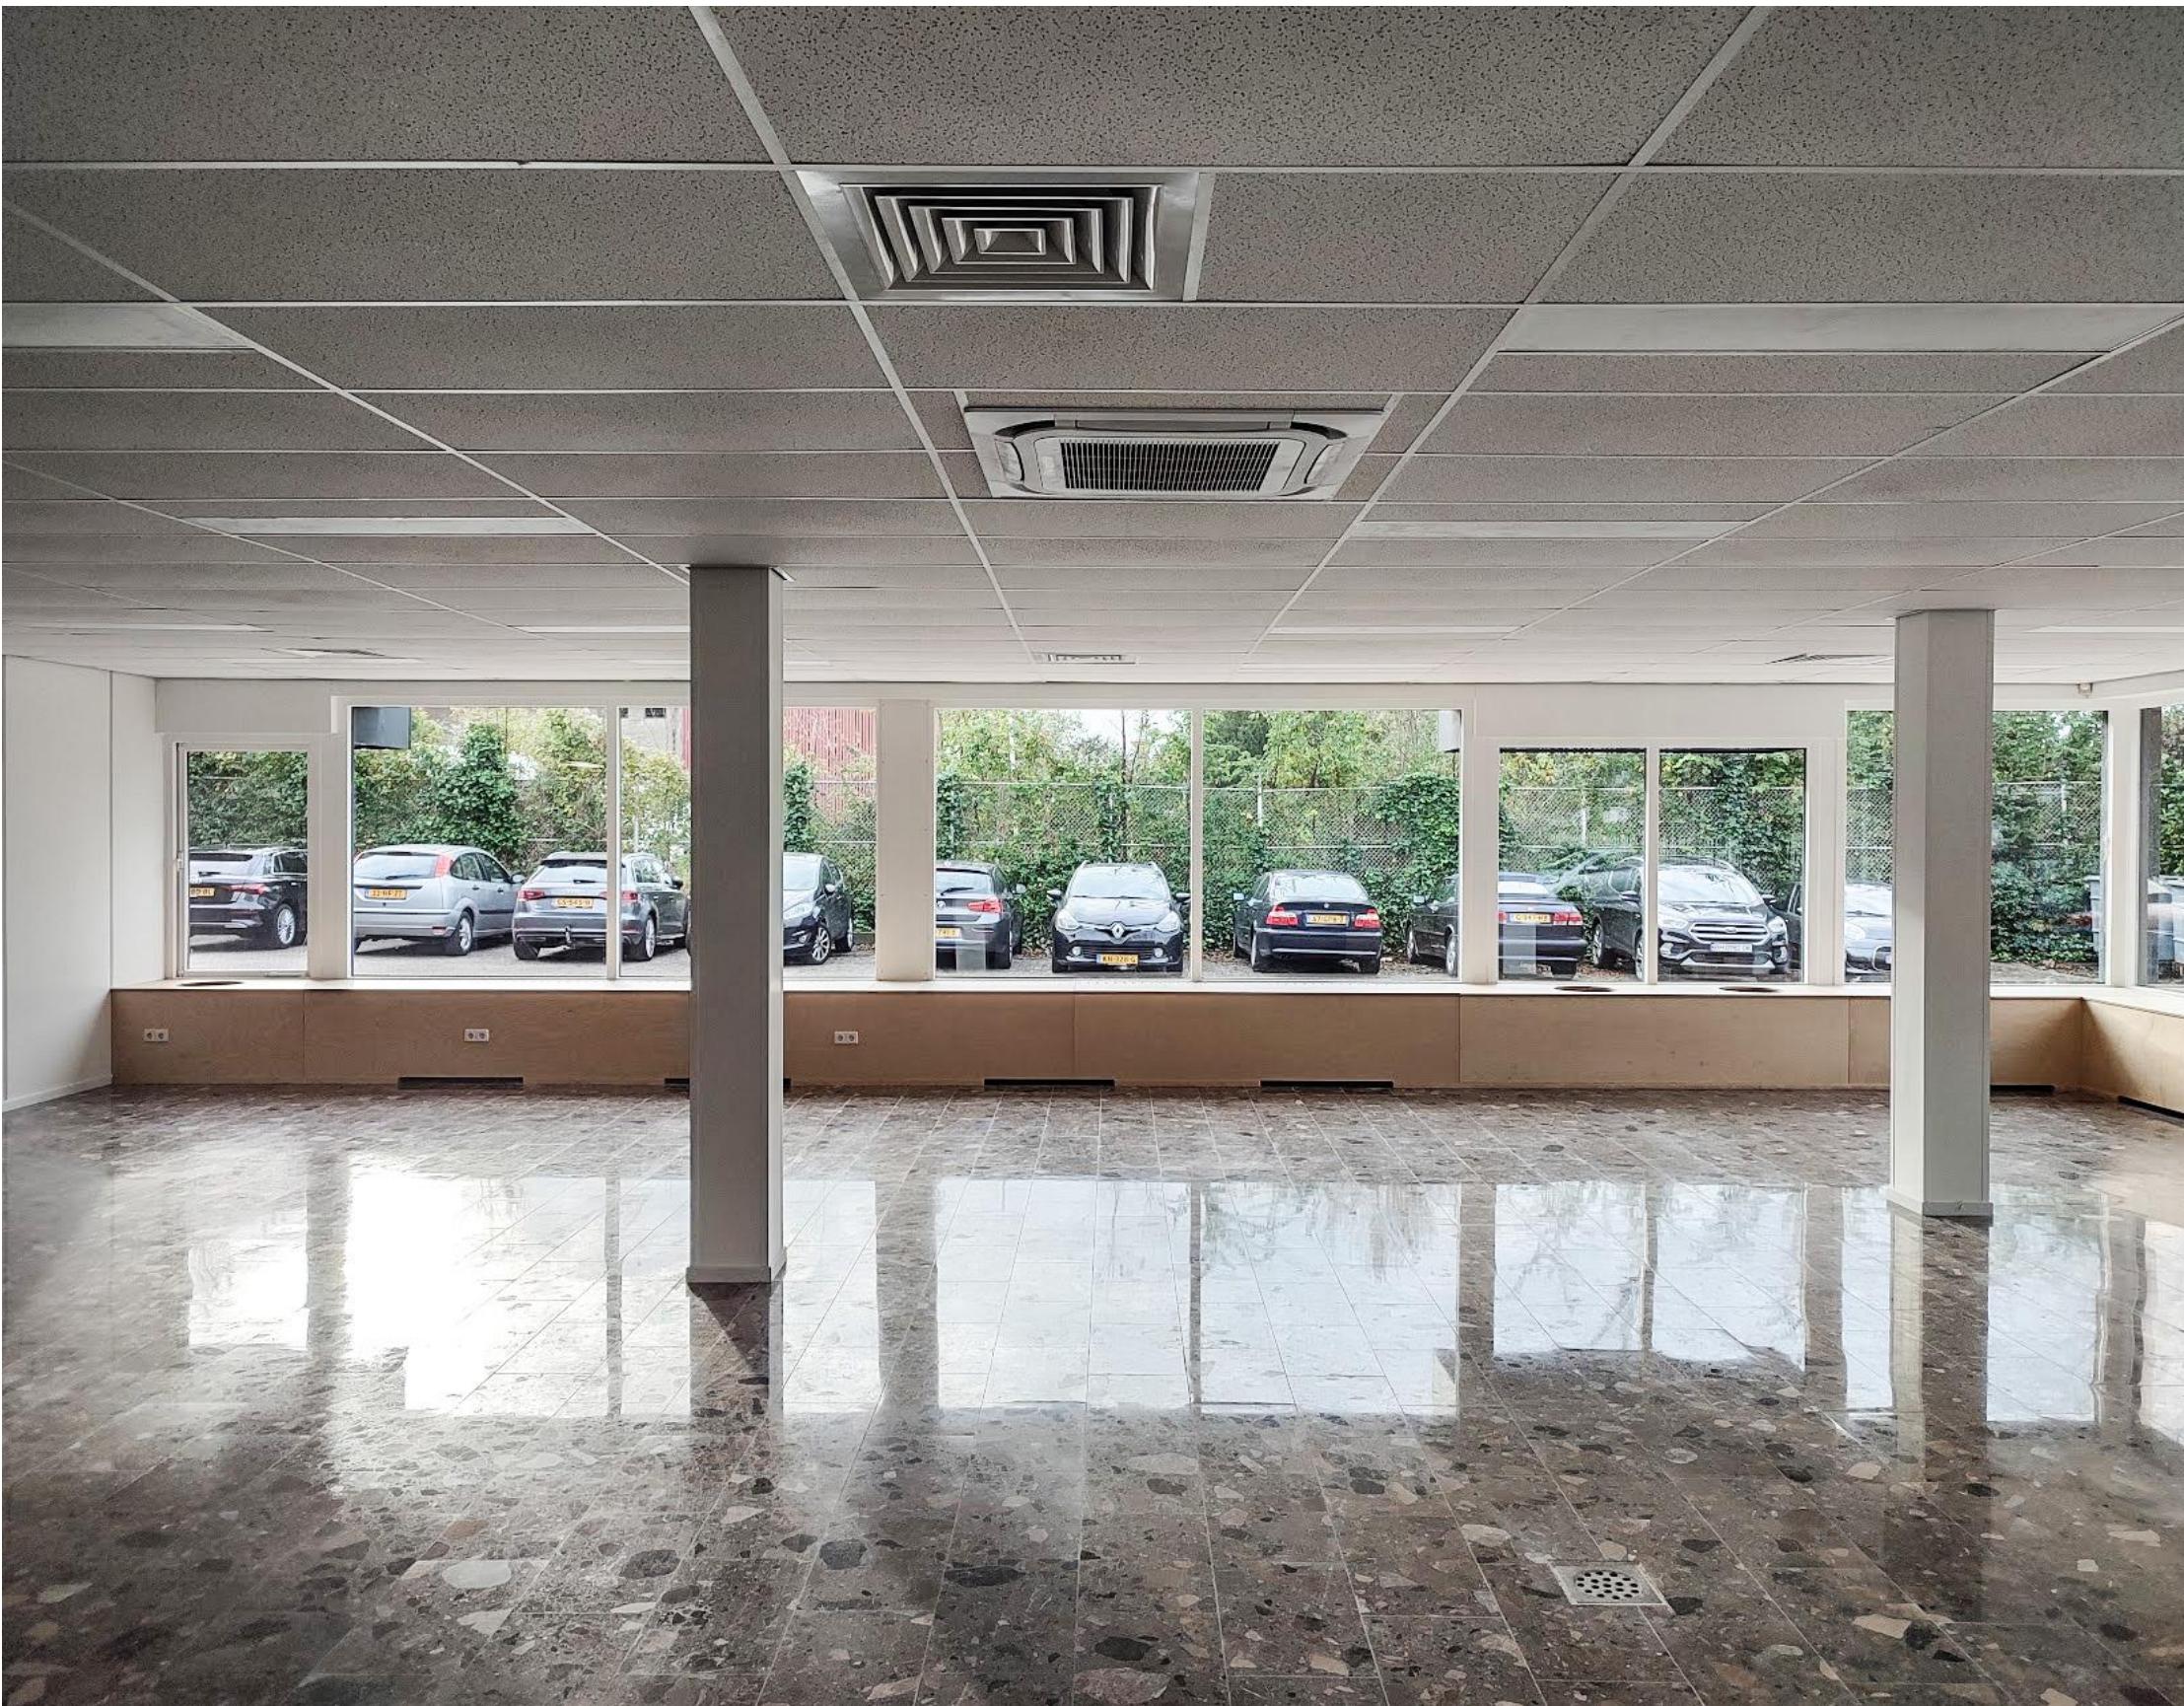
Exterior wooden canopy (lifel) box reshaping, plastering and repainting 2 entrances
Exterior concrete step with tiles (main entrance)
600x600x20 exterior tiles)
Floor hatches 1 stone hatch with slab renovation + 2 laminate hatches
Old main entrance exterior wooden walls removal
Door rotation new entrance
Making vent opening in the welding zone
Old kitchen floor additional works (screed demolition, screed pouring, laminate laying)
Additional drainage connection to the coffee machine (concrete cutting + plumbing works)
BB's glass door adjustment
Replacement of all damaged ceiling panels

Additional hours for Maarten's list
Additional water and drainage connection in the canteen
Additional hours of floor restoration (old entrance)
Terrazzo stone extraction from old kitchen
Floor sanding and polishing 266 sq.m
Additional renovation works for toilet refurbishment - Radiators removing and installing
Temporary roof waterproofing
Additional hours due to changing the LBK position after constructional drawings
