HAND-OVER BOOK

S3

Sustainable Space Solutions B.V.

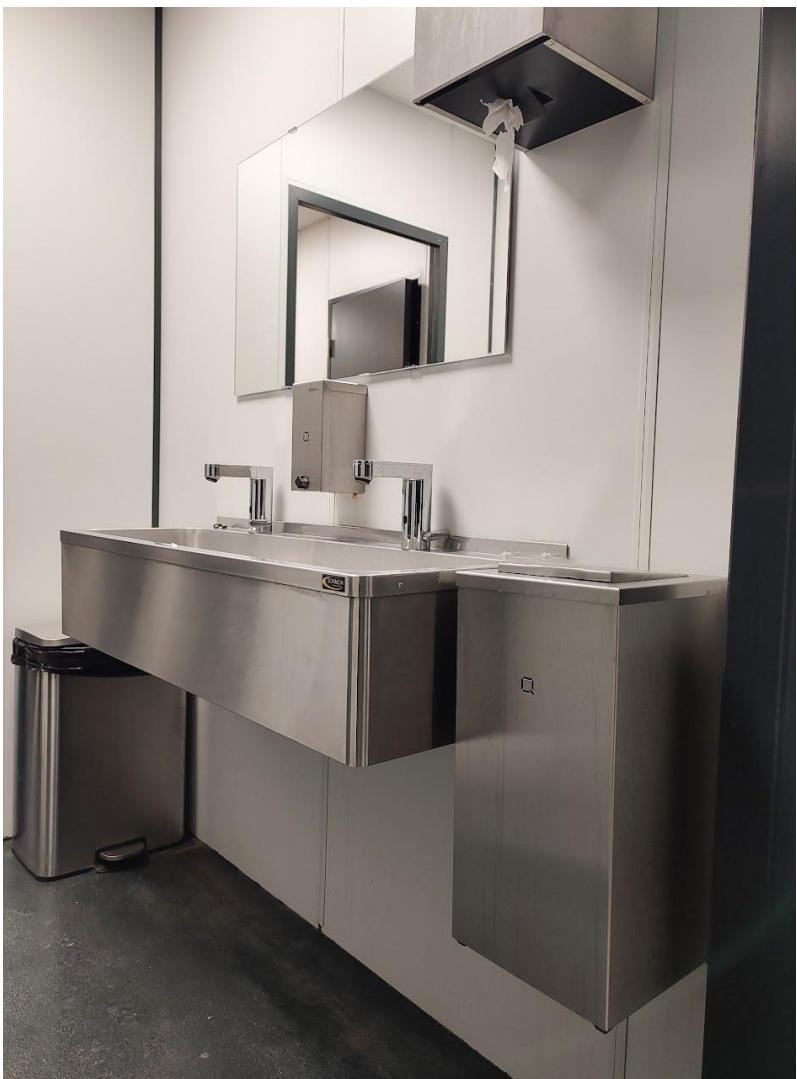
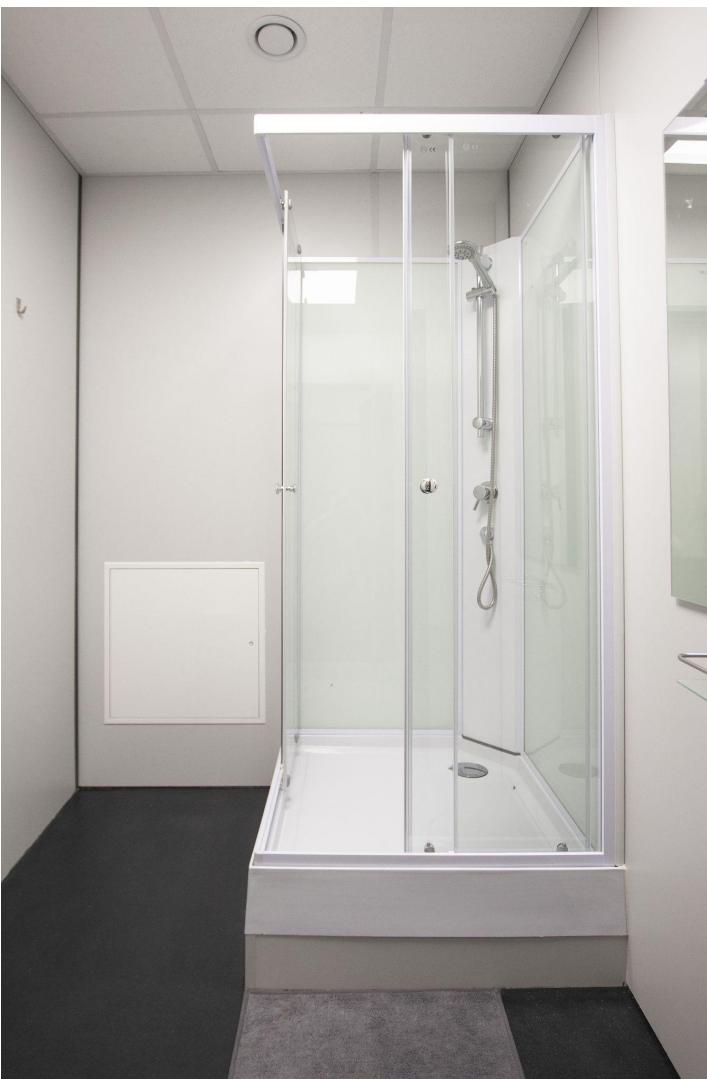
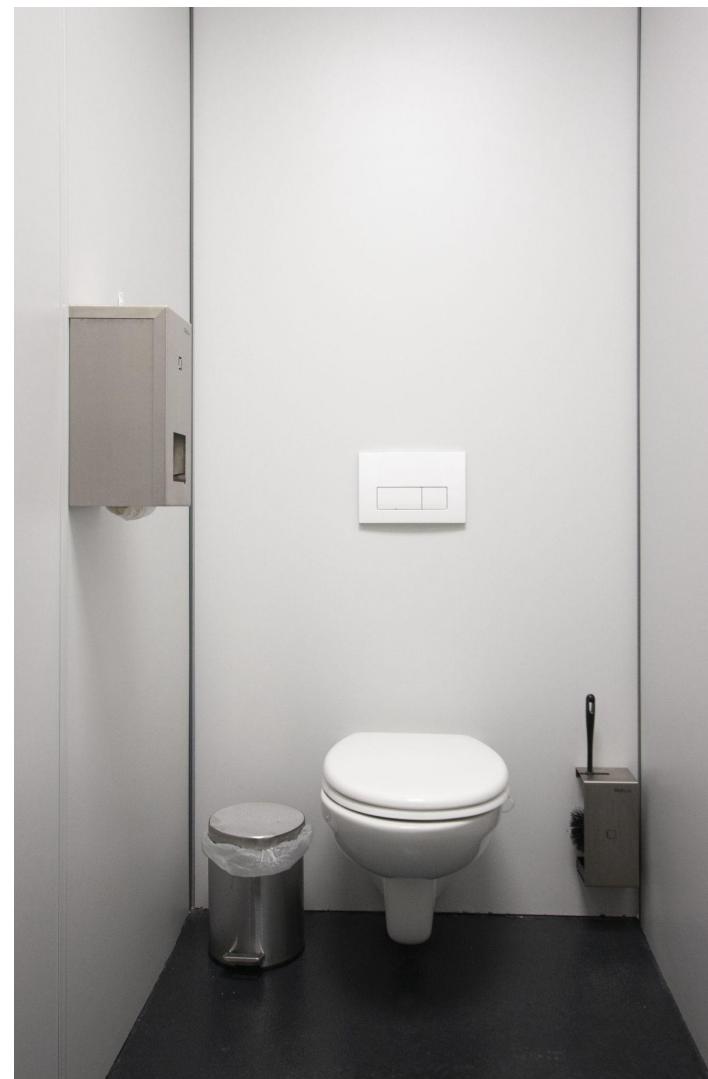
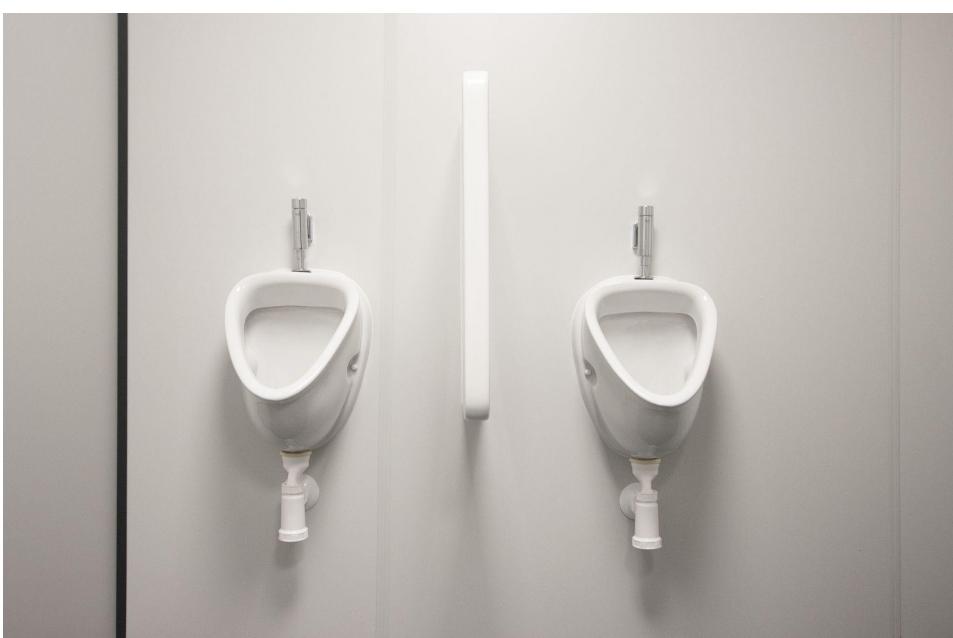
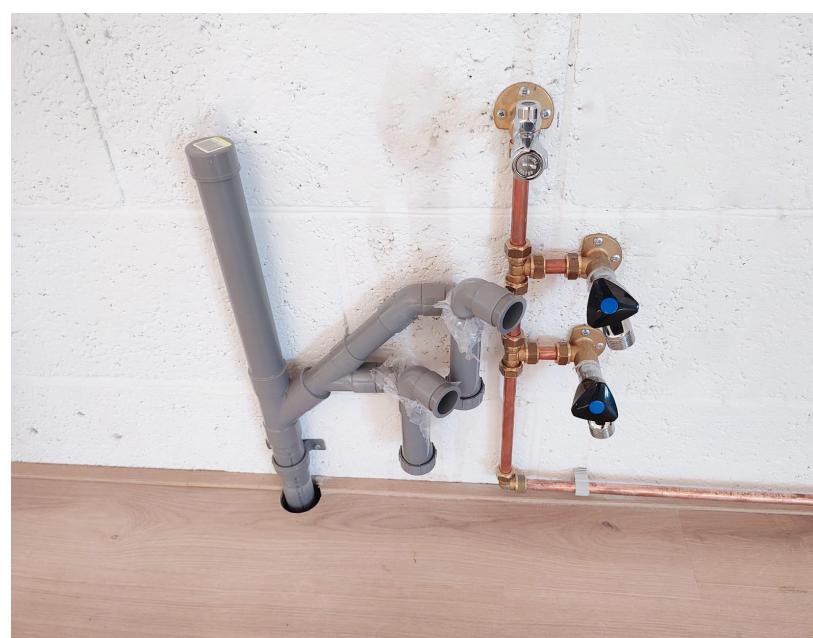
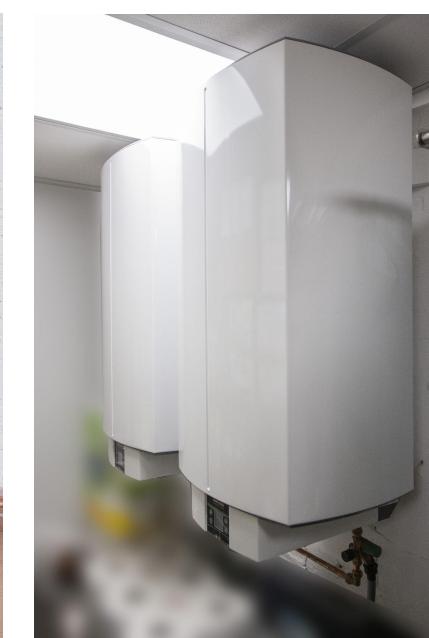
2.6 PLUMBING Workshop

Description:
Supplied and installed: <ul style="list-style-type: none">• kitchen water sewerage connections in the canteen and teamhonk• installed double sink with 2 taps• Installed 2 boilers• installed 4 toilets• installed 4 urinals• installed 3 shower cabins• installed 2 connections for washing machines and 2 dishwasher machines.• Isolated the water pipe under the roof.
Internal maintenance/Repairs/Orders:
Clean all drainages in time due to heavy use to avoid blocking of the sewerage.
External maintenance/Warranty:
See material warranty from the supplier for the boiler equipment and other sanitary equipment.
Links to files:
Scheme of the plumbing: CEAD confidential
Specific alerts/warnings/remarks:
Do not change the settings of the boilers. Contact maintenance company to adjust the settings during their visit. System currently connected to 60A and optimized to fit consumption requirements.

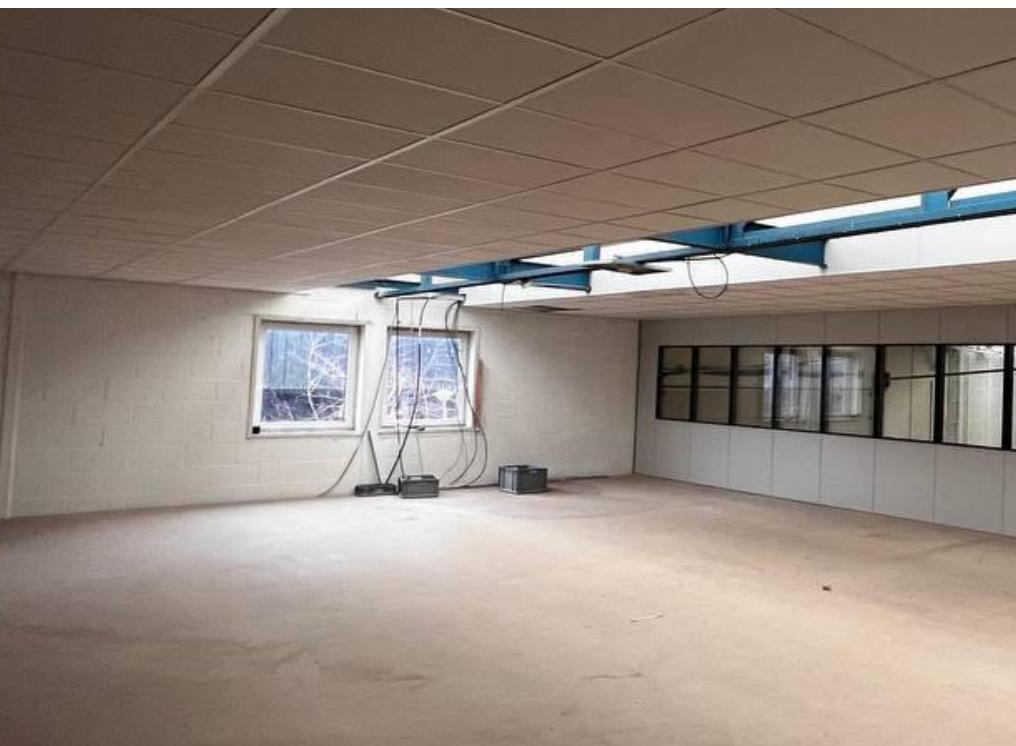
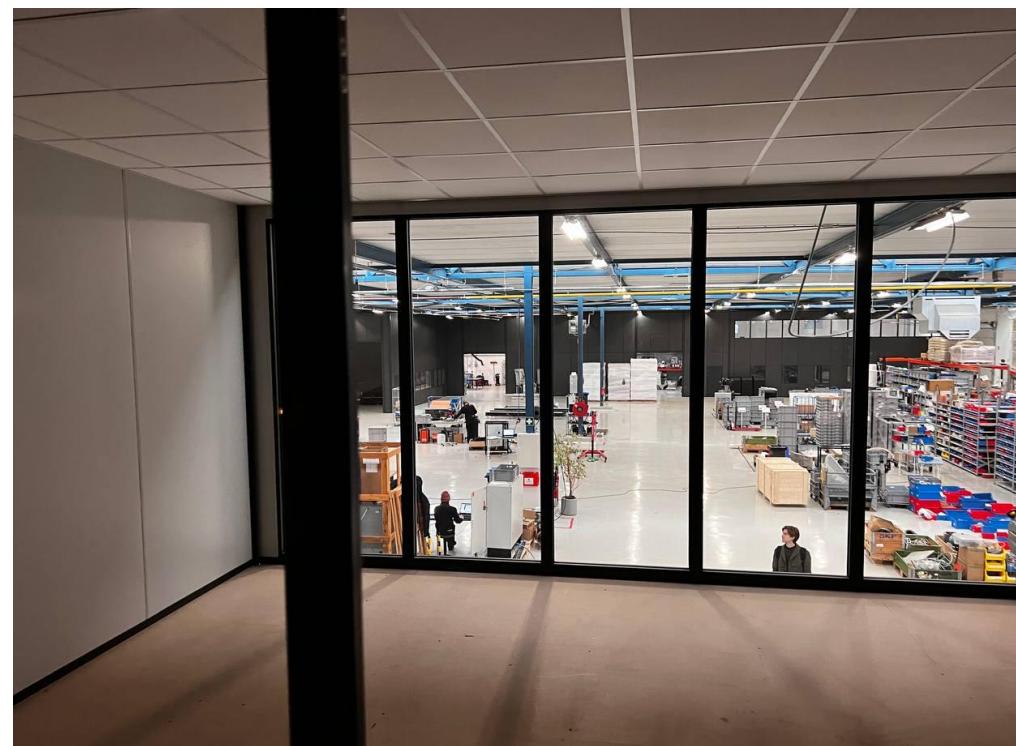
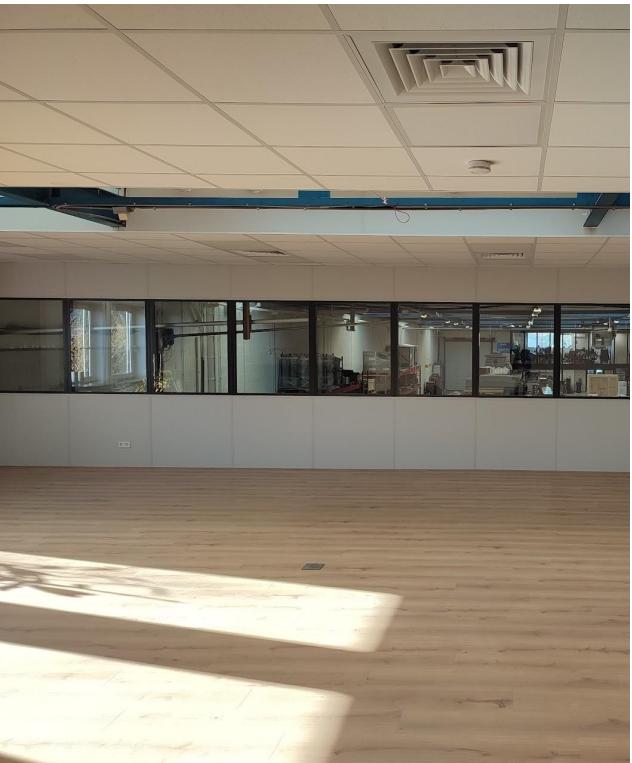
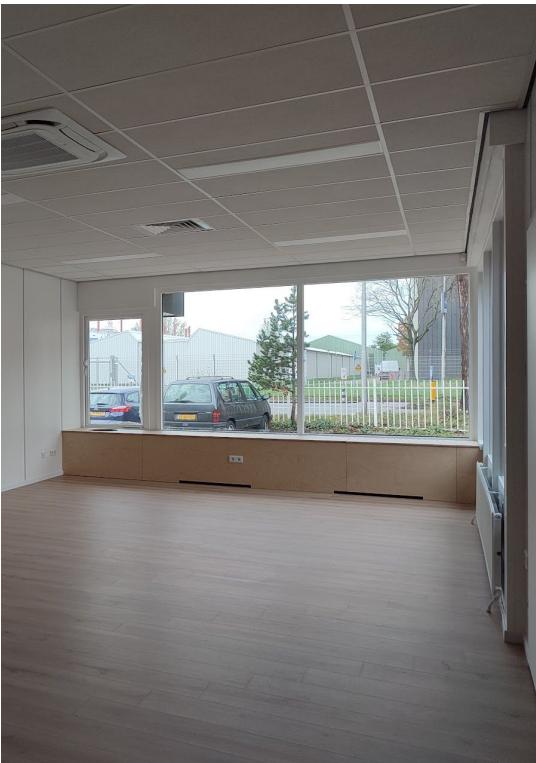
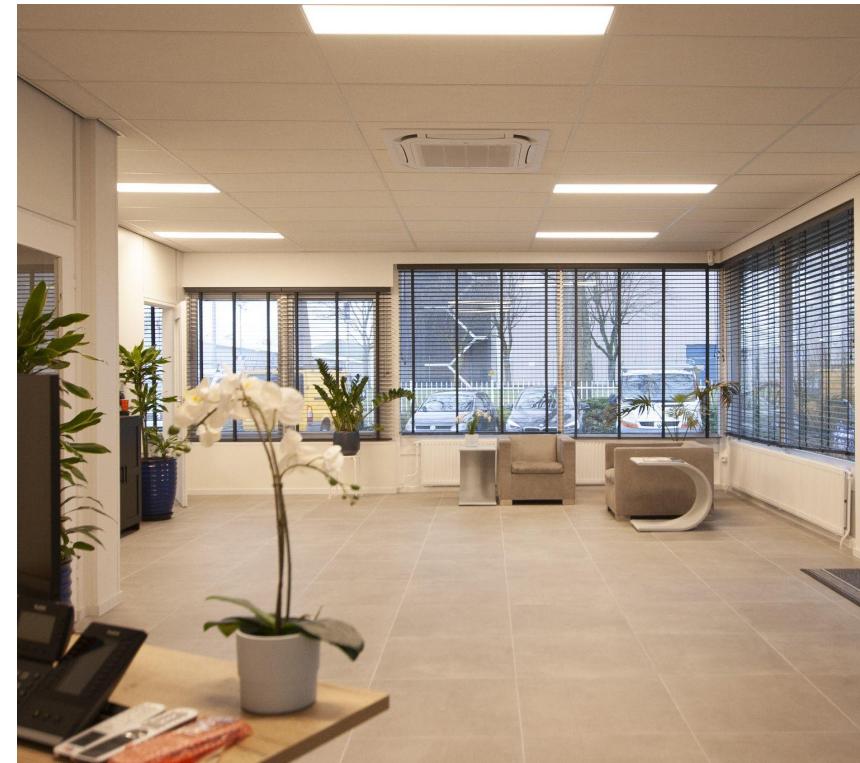
2.7 FLOORING

Light wood laminate, skirting board and underlay was provided by CEAD.

- 384 m2 (mezzanine+canteen)
- 219 m1 of skirting board
- 47 m2 of grey tiles (new entrance zone)

This laminate is not waterproof so try to avoid wet cleaning only dry and half dry and check and protect laminate in the places of potentially possible leakages.

Only dry and half dry cleaning without active chemicals. Use rubbers and felt for the furniture and floor standing equipment.

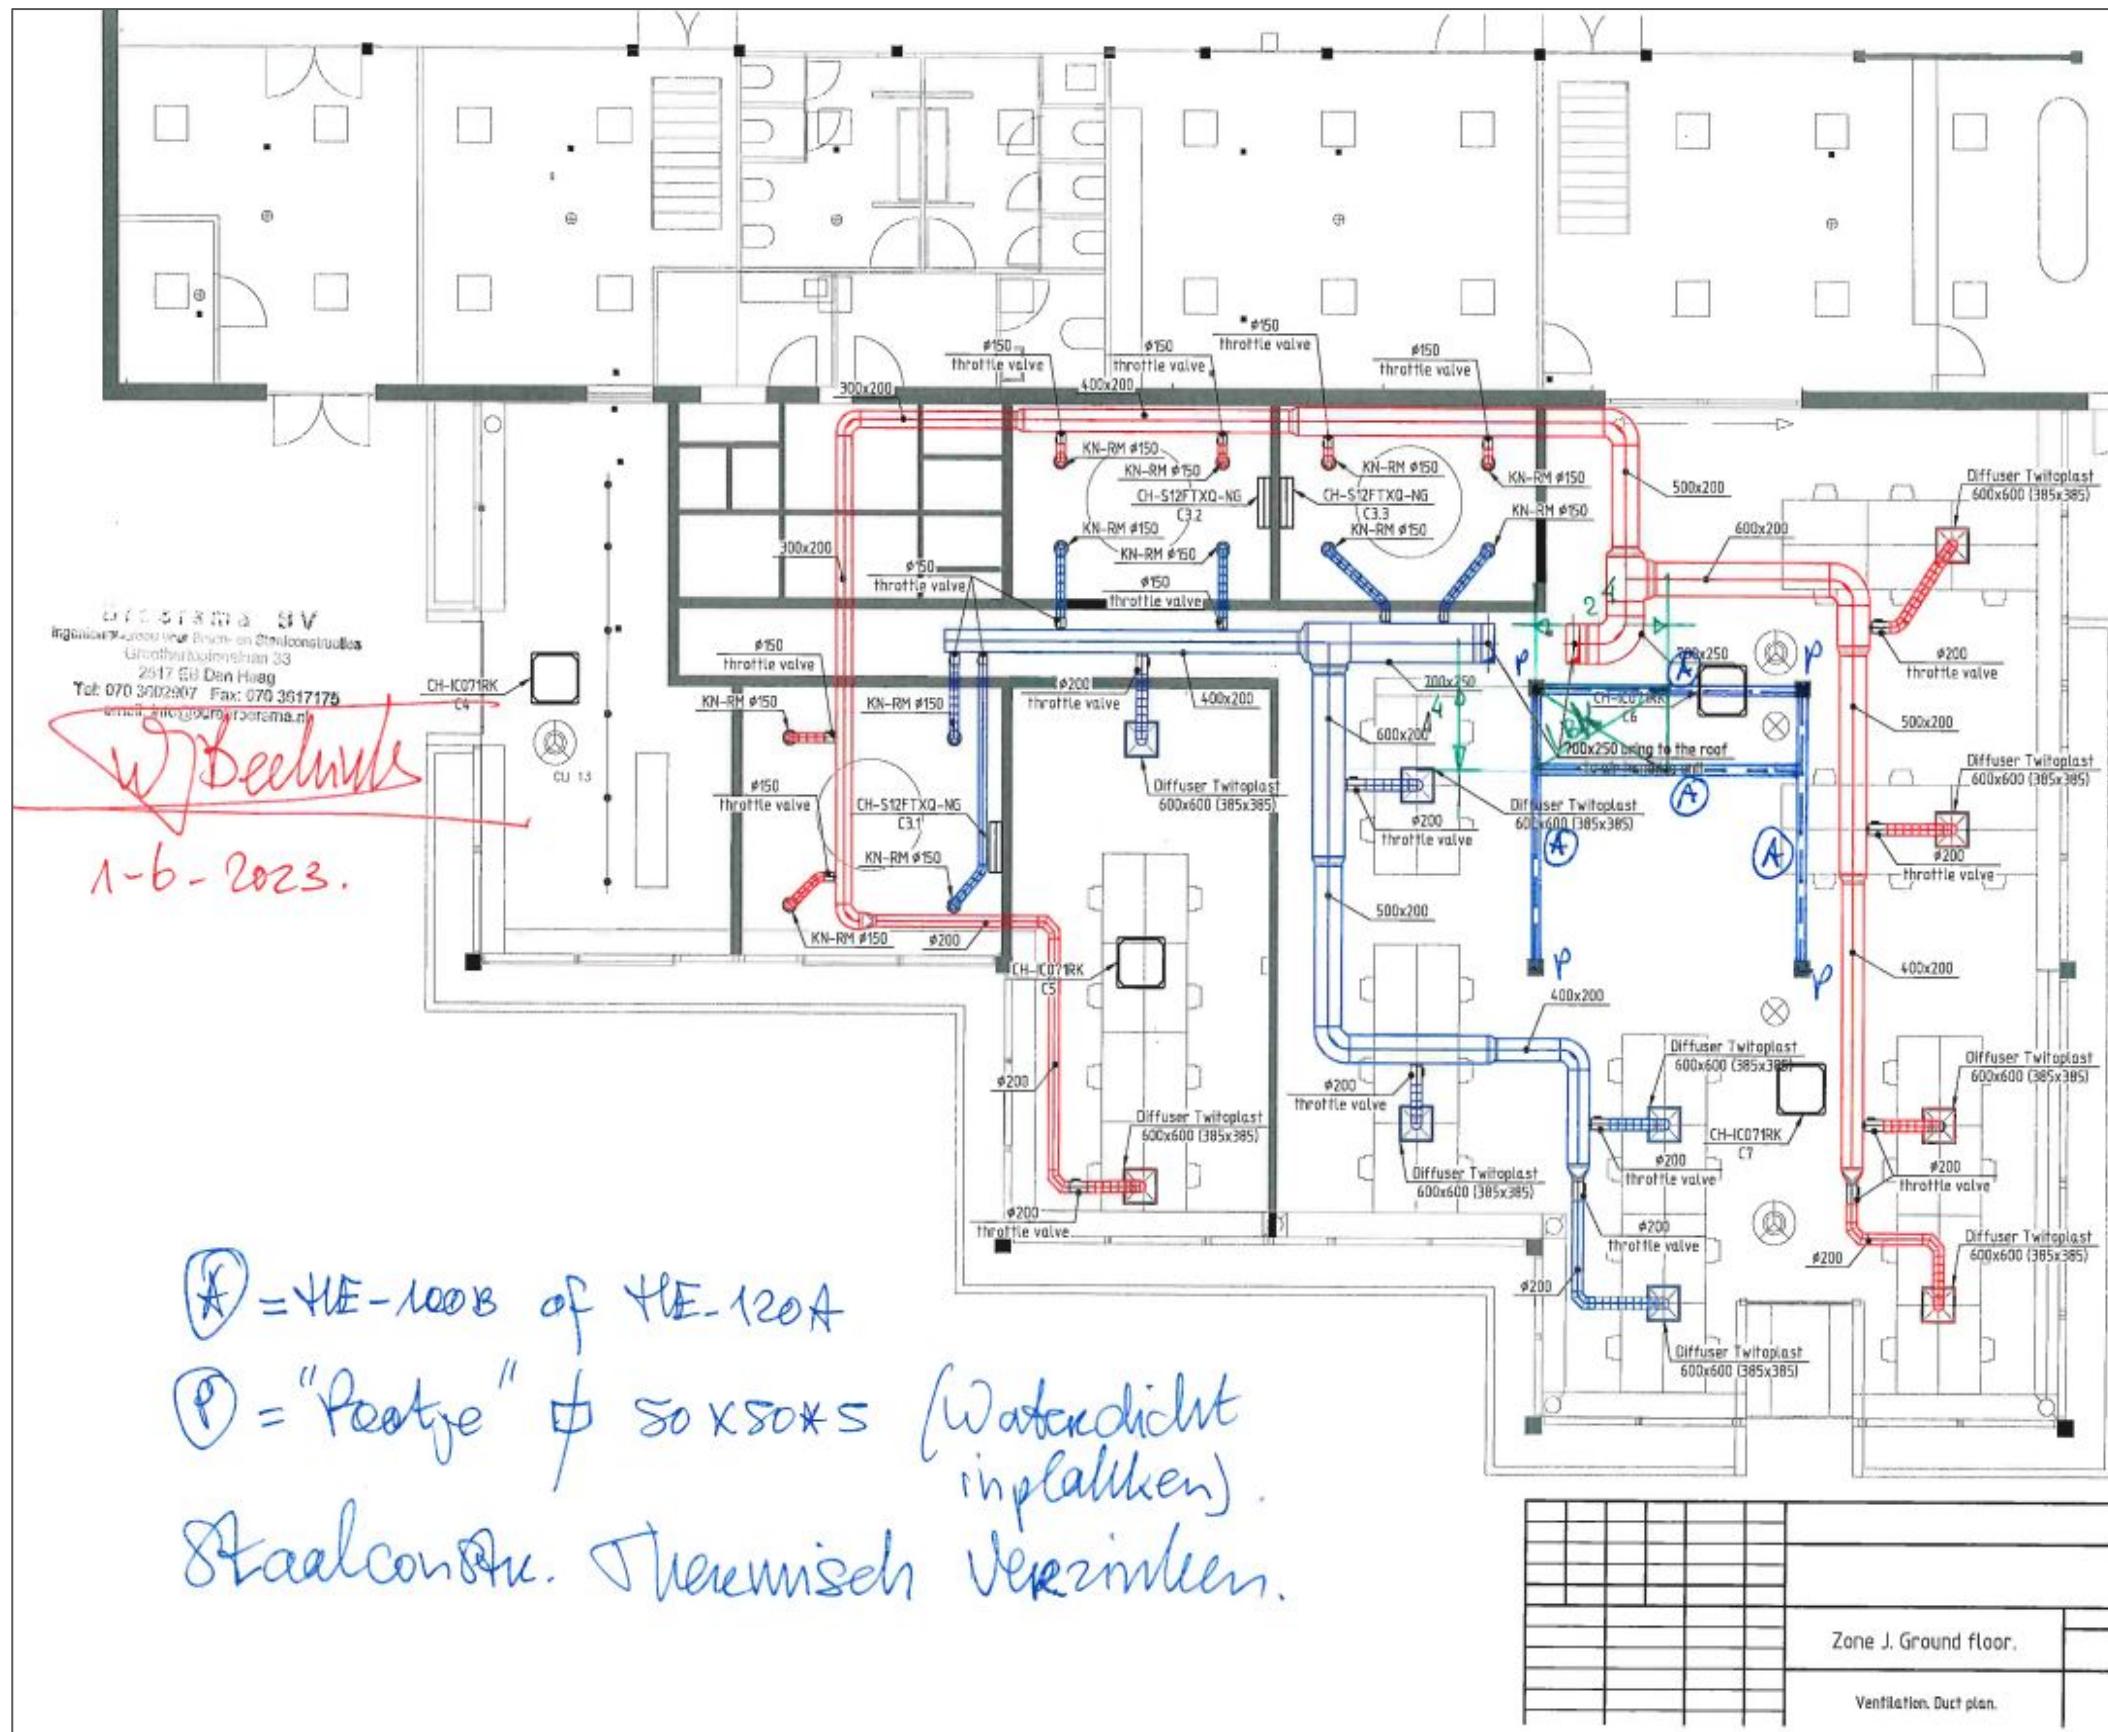
3.1 ROOF Constructional engineering scheme

Company Bureau Broersma visited the location, studied the archive drawings and made measurements on the location and made a constructional scheme for metal frame for ventilation exterior unit that is connected to the columns of the building to avoid additional load on the old roof due to it's condition.

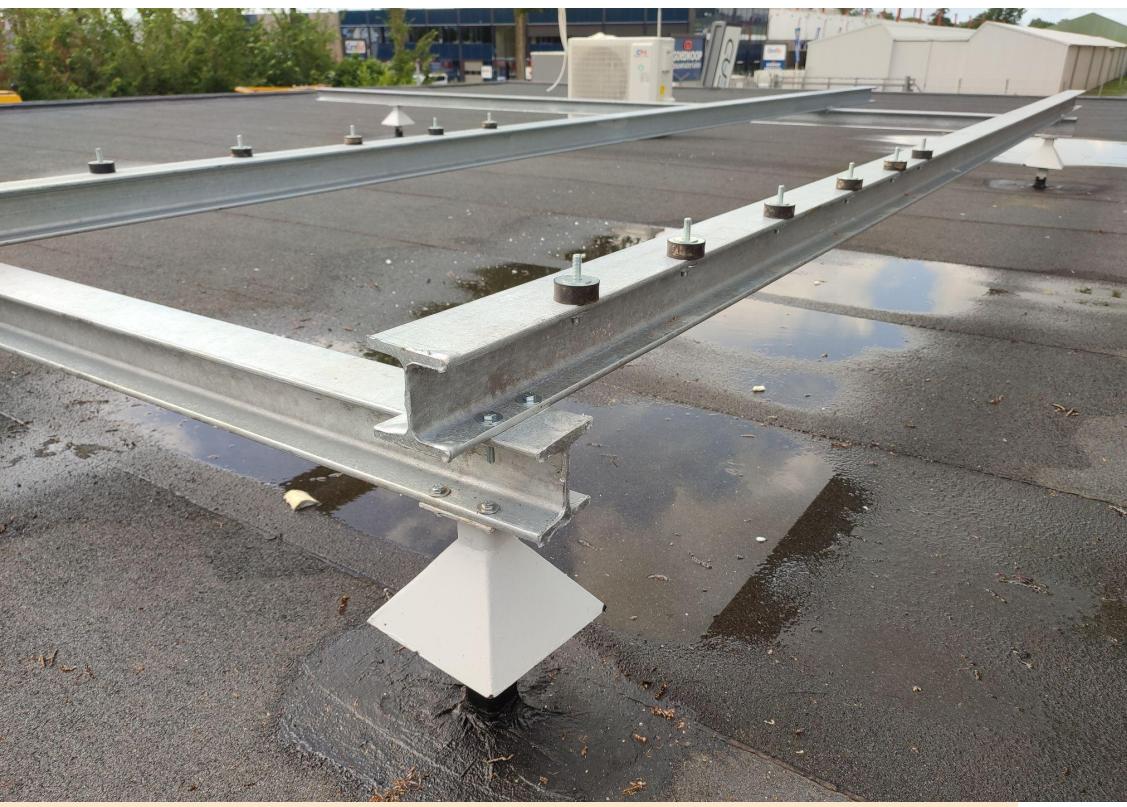
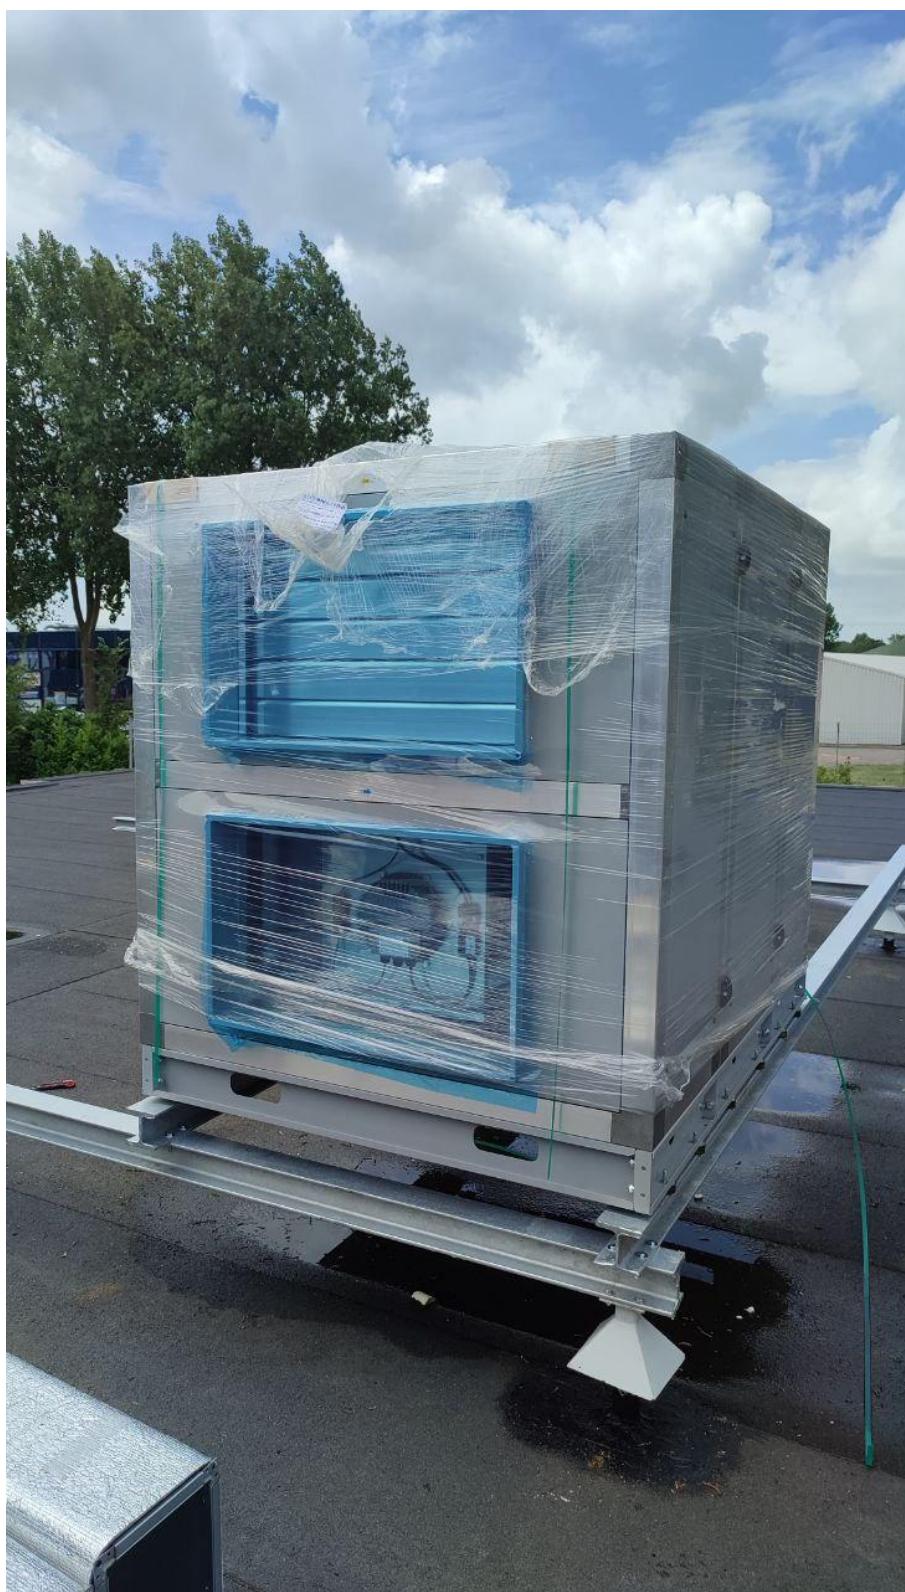
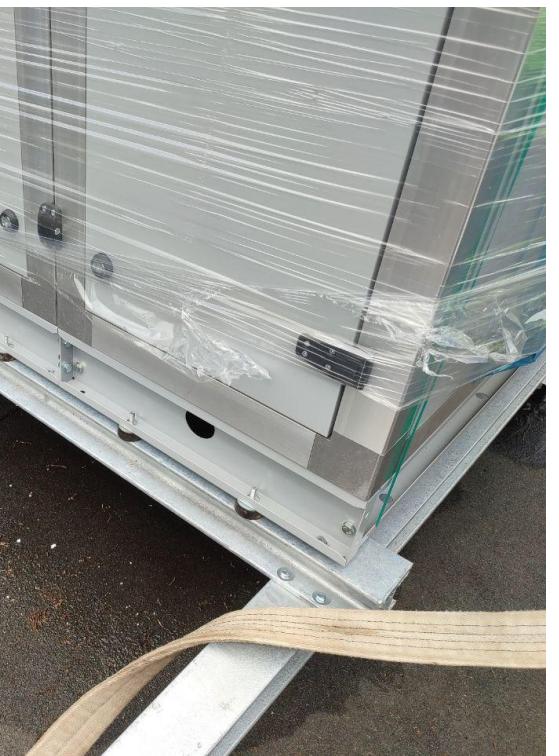
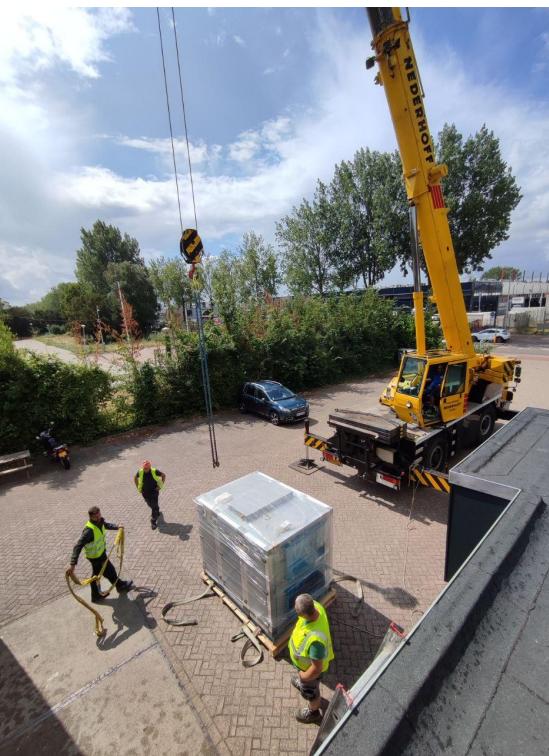
3.2 METAL FRAME For LBK

Company MKZ supplied metal elements.
Beams EN 10025 EN 10034 HEB100 S235JR Zinked

Make visual checks. After 3 years whether coating degradation would become visible painted element should be covered with additional layer of exterior paint appropriate for metal.

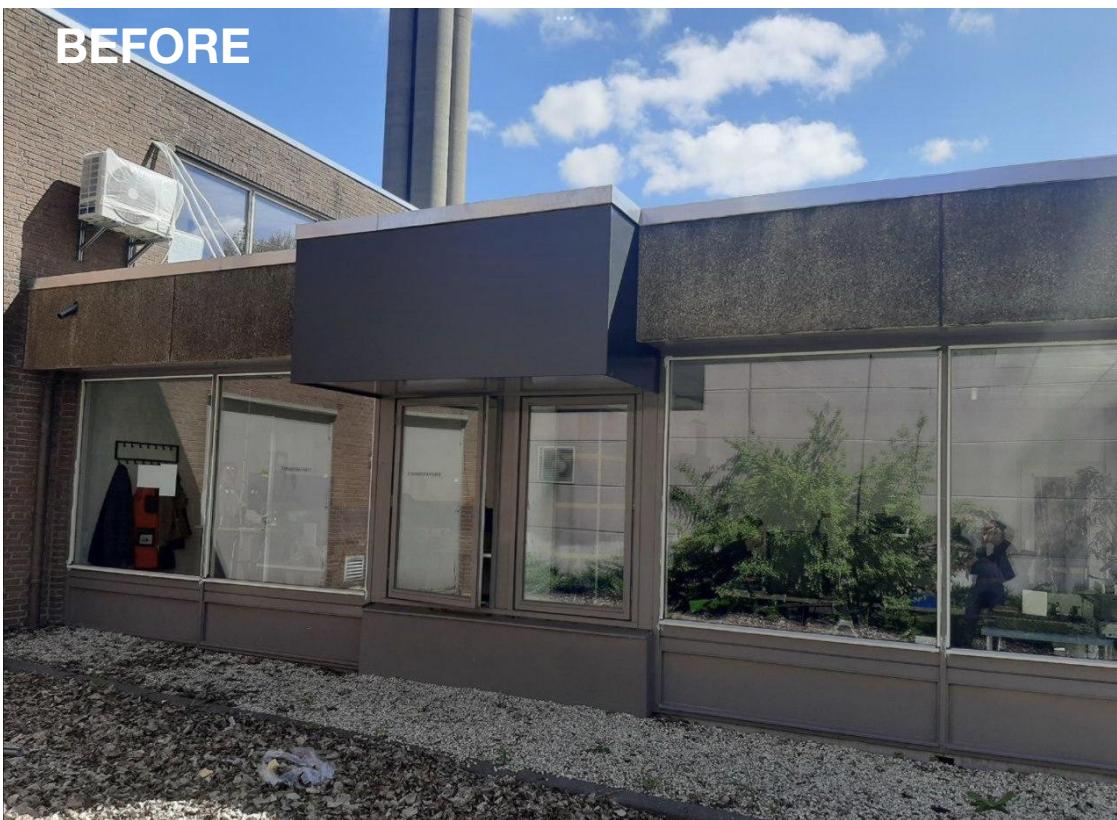
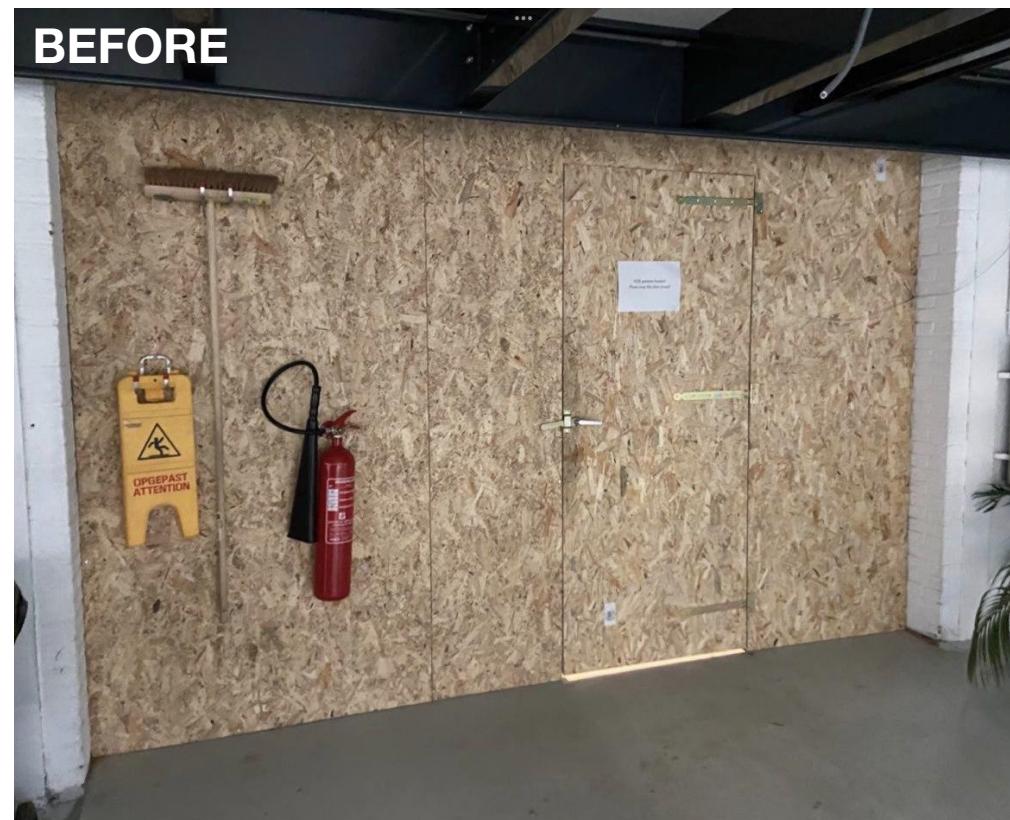
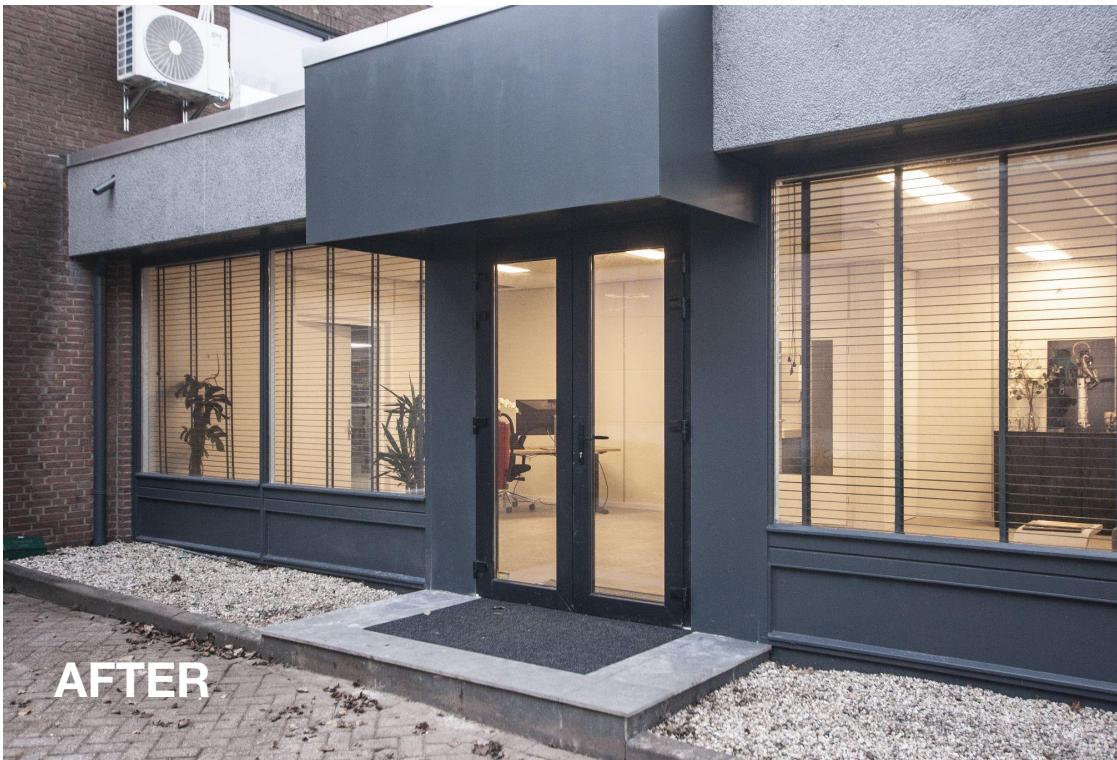
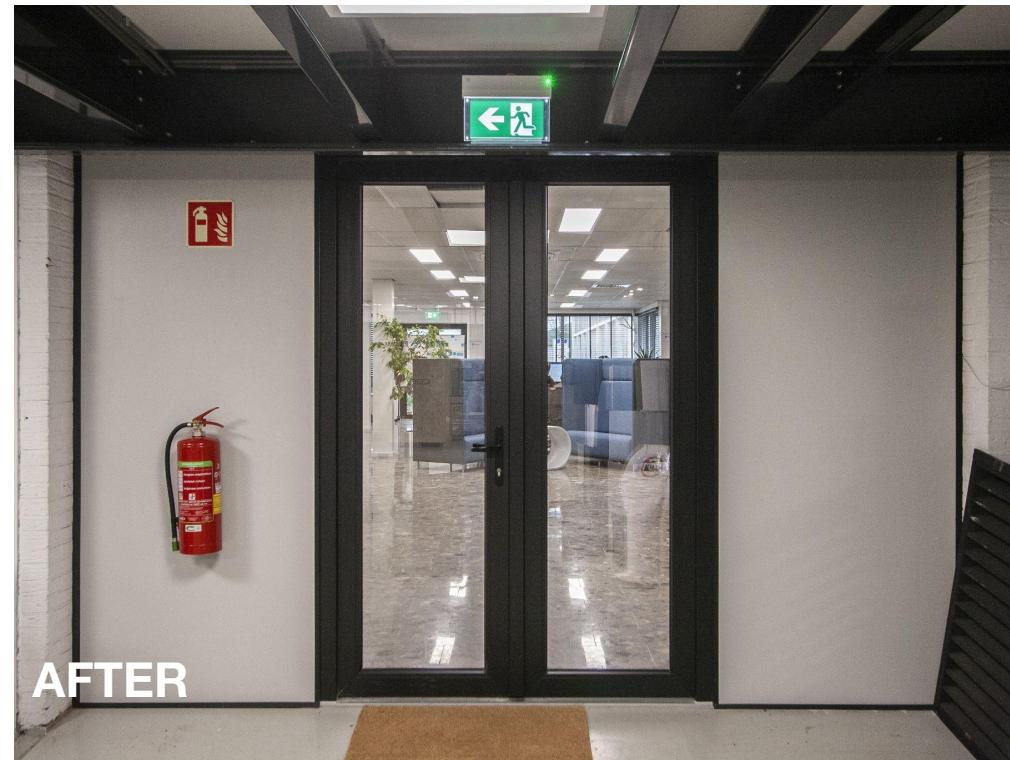
3.13 NEW ENTRANCE DOORS + wooden indoor wall replacement

Installation of 2 new sets of double doors including sourcing and buying materials and all installation works. The aim is to have doors with double layered glass if possible within this budget.

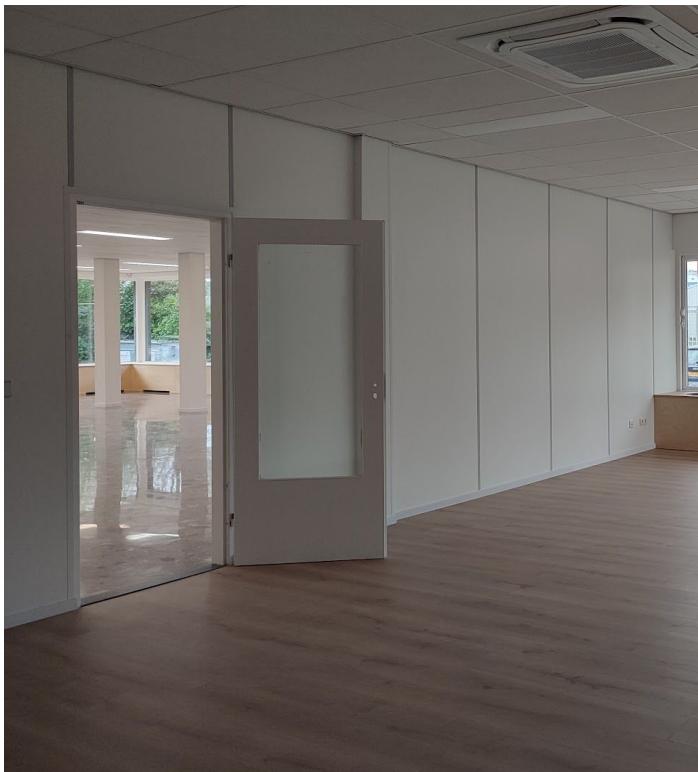
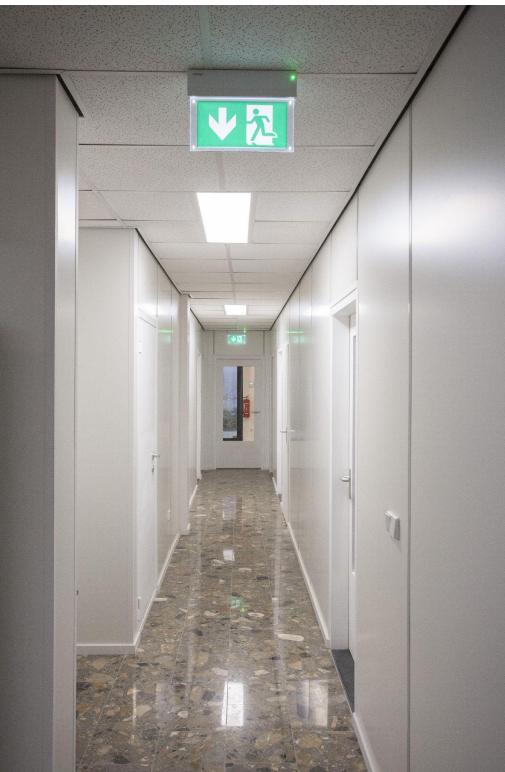
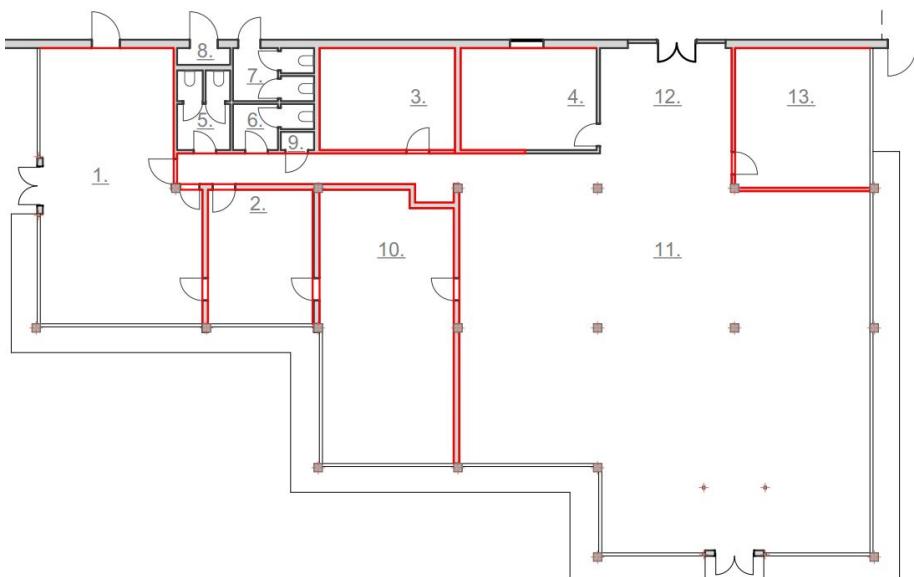
3.14 OFFICE WALLS Plastering & painting (interior)

Installation of the wall particle board panels and readjusted the electrical fixtures on the walls. 320 sq.m. of panels.

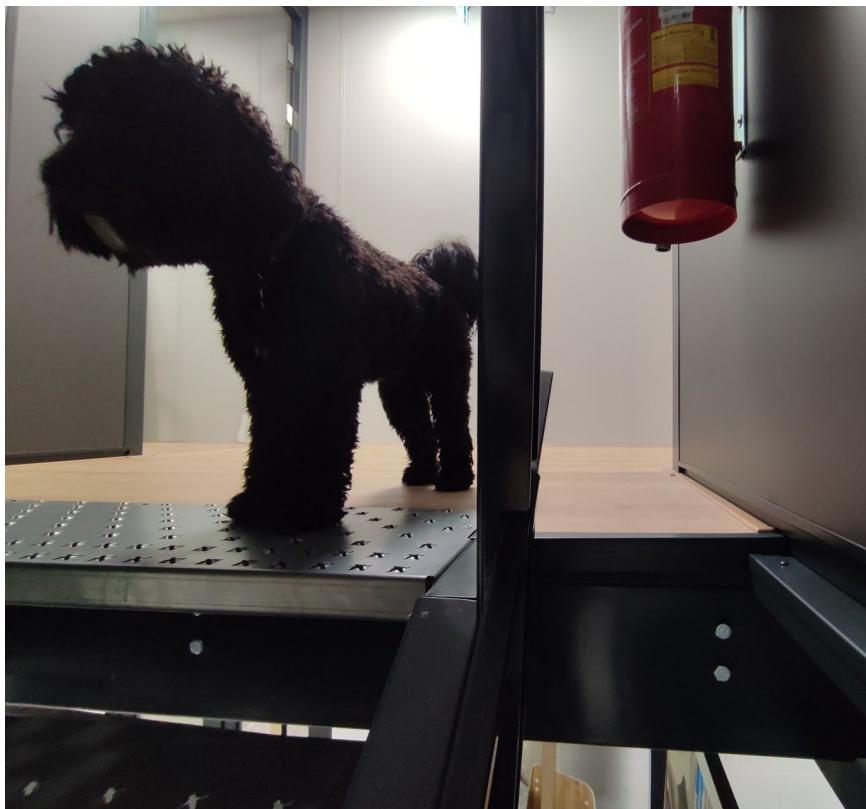
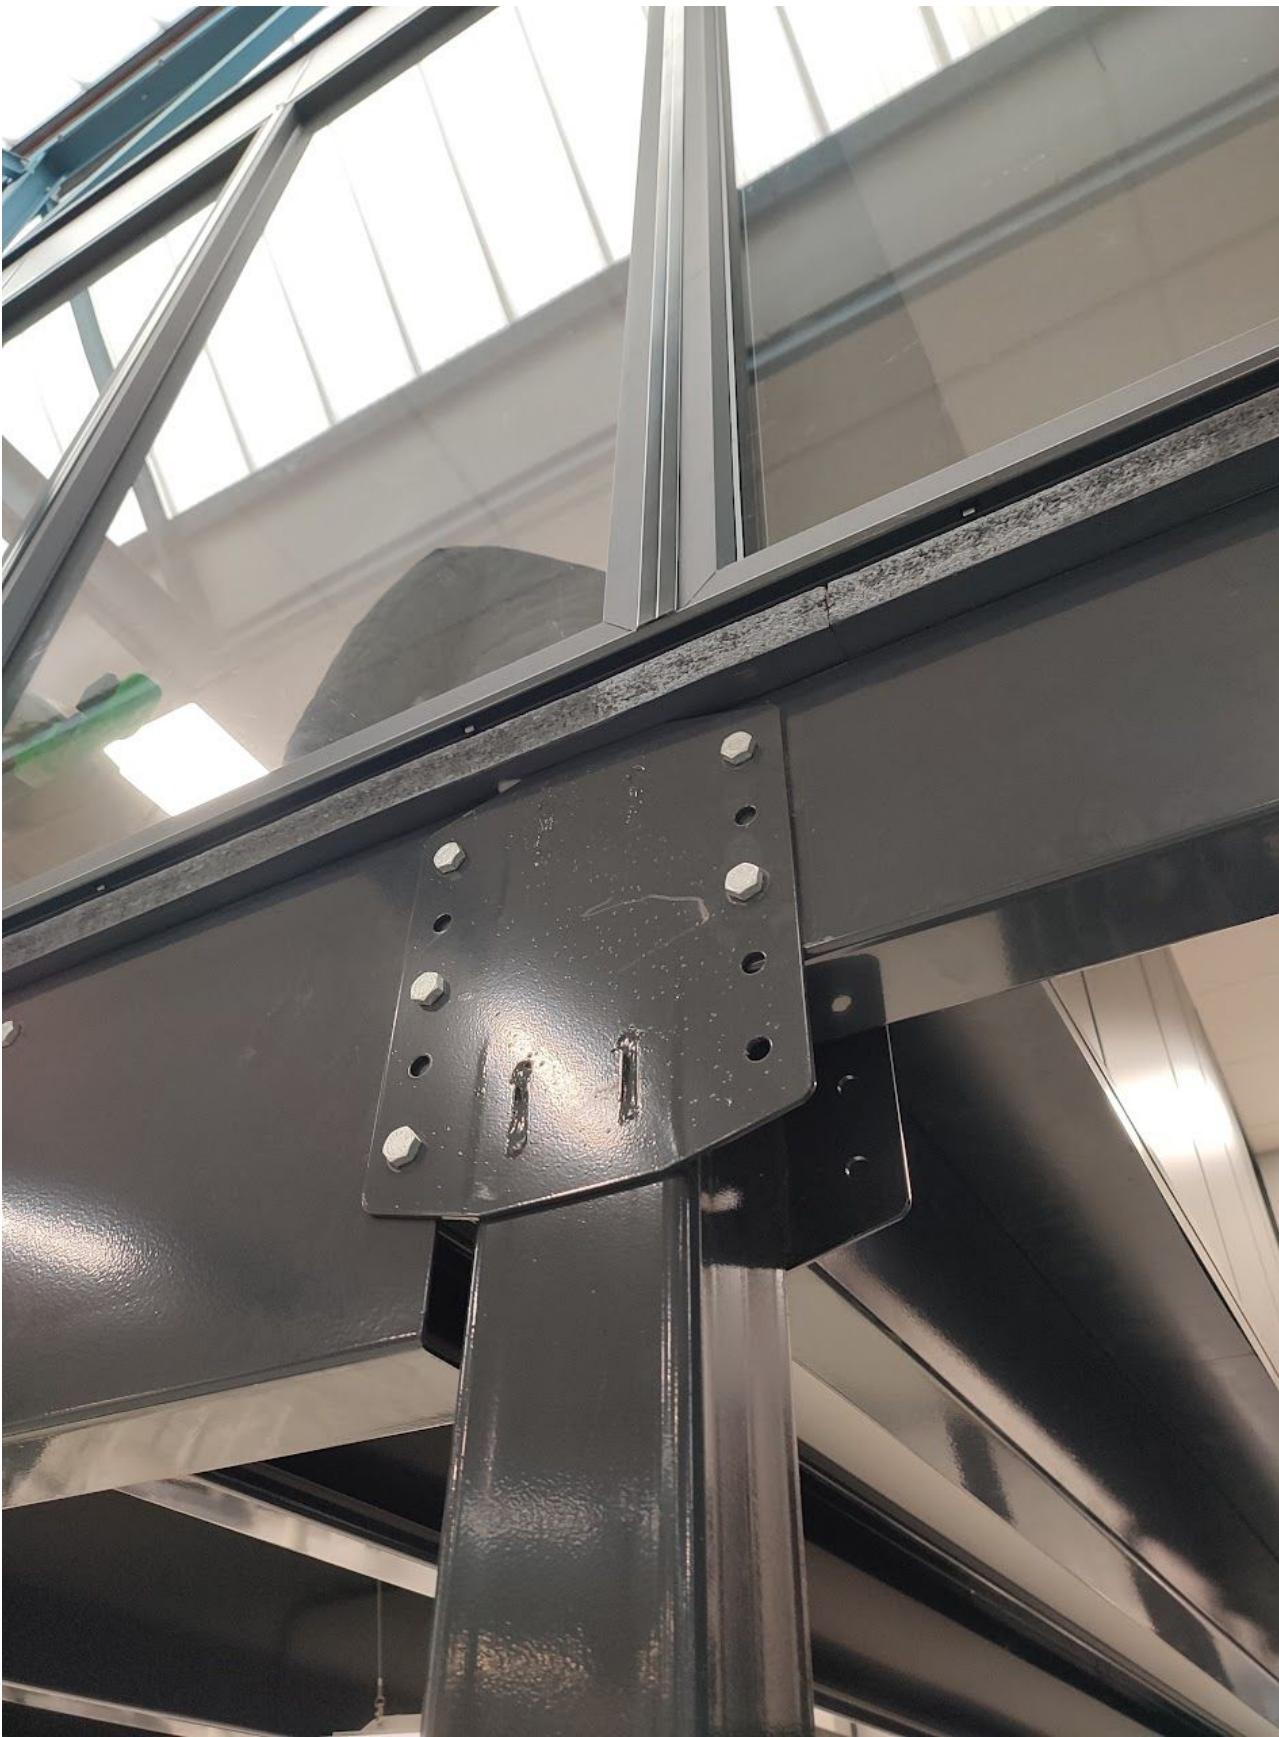
3.16 PAINTING WALLS Mezzanine OSB painting parts works

Painting in RAL 7019 colour visible parts of the mezzanine floor
