HAND-OVER BOOK

S3

Sustainable Space Solutions B.V.

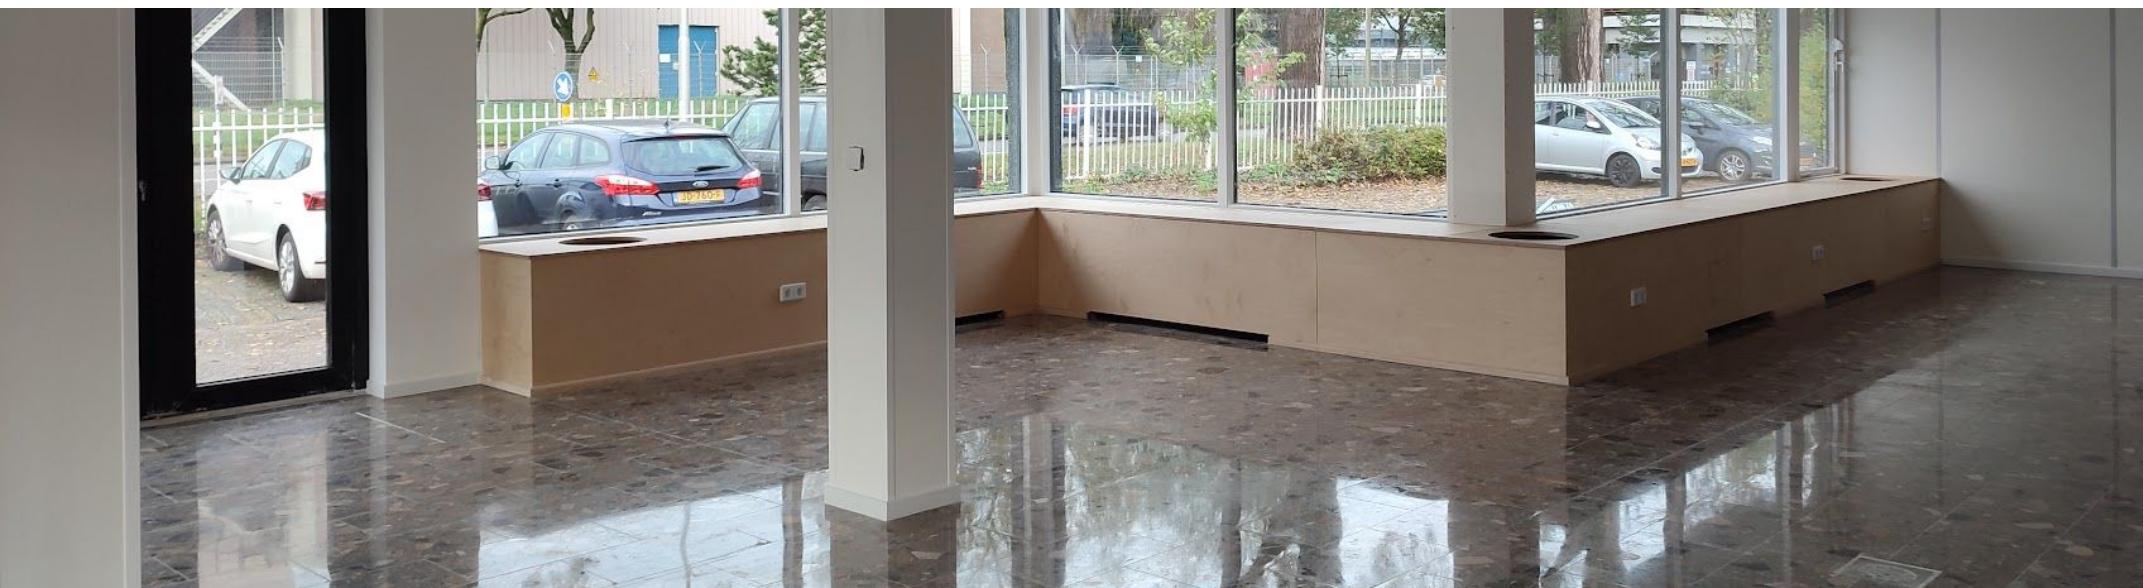
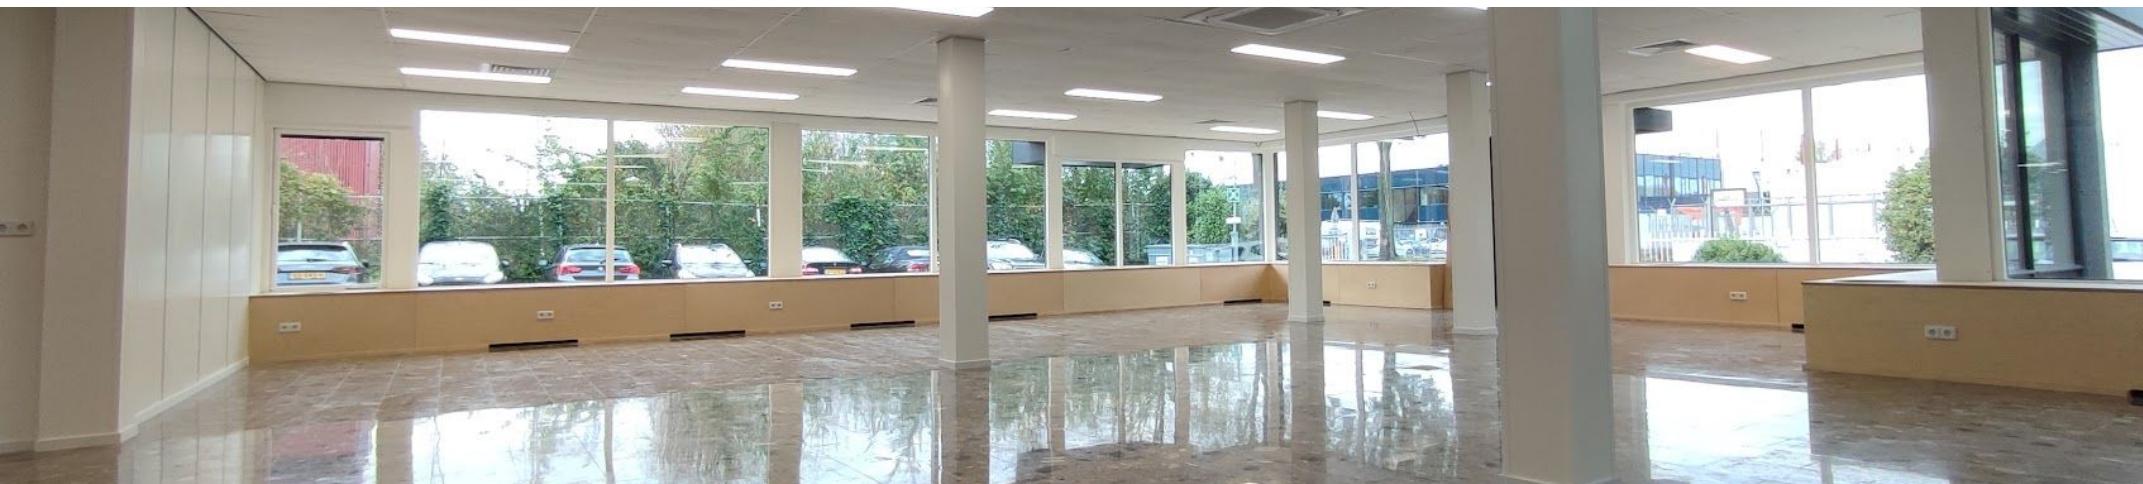
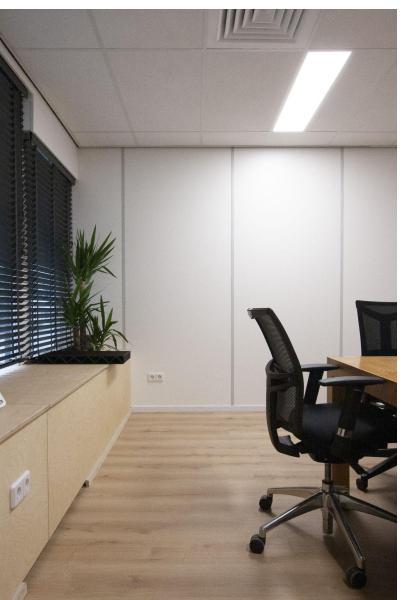
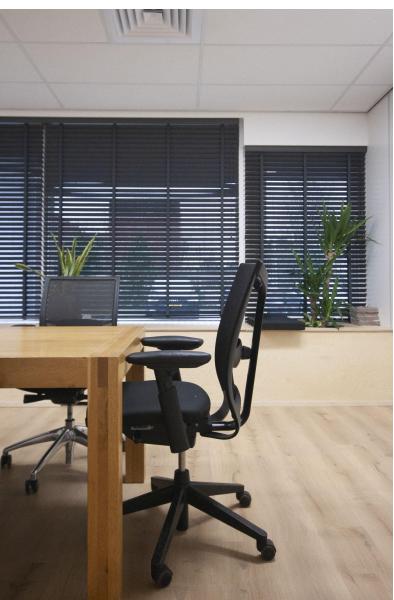
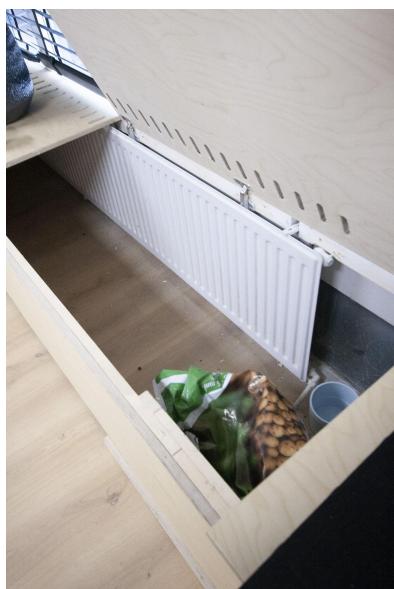
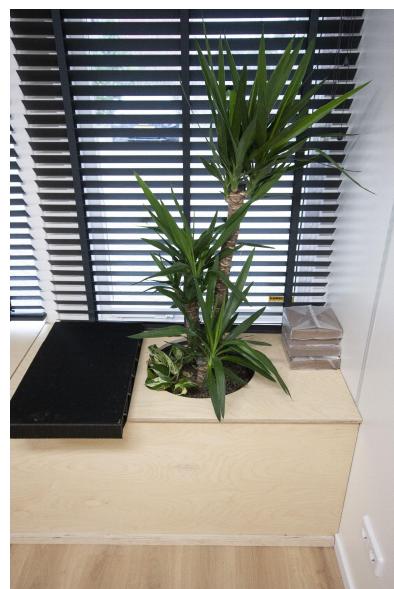
3.20 BENCH Works

Making the “bench” on inside of facade to cover cable management etc. and also to function as storage/seats with openings for plants integration. 40.87 m1 of the “bench”

Water the flowers and plants with special attention to avoid overflows to protect the cable gutters from water and moisture

Each 2.5-3 years the additional layer of cover should be applied to protect the birch plywood and avoid possible imperfections that could be caused during use.

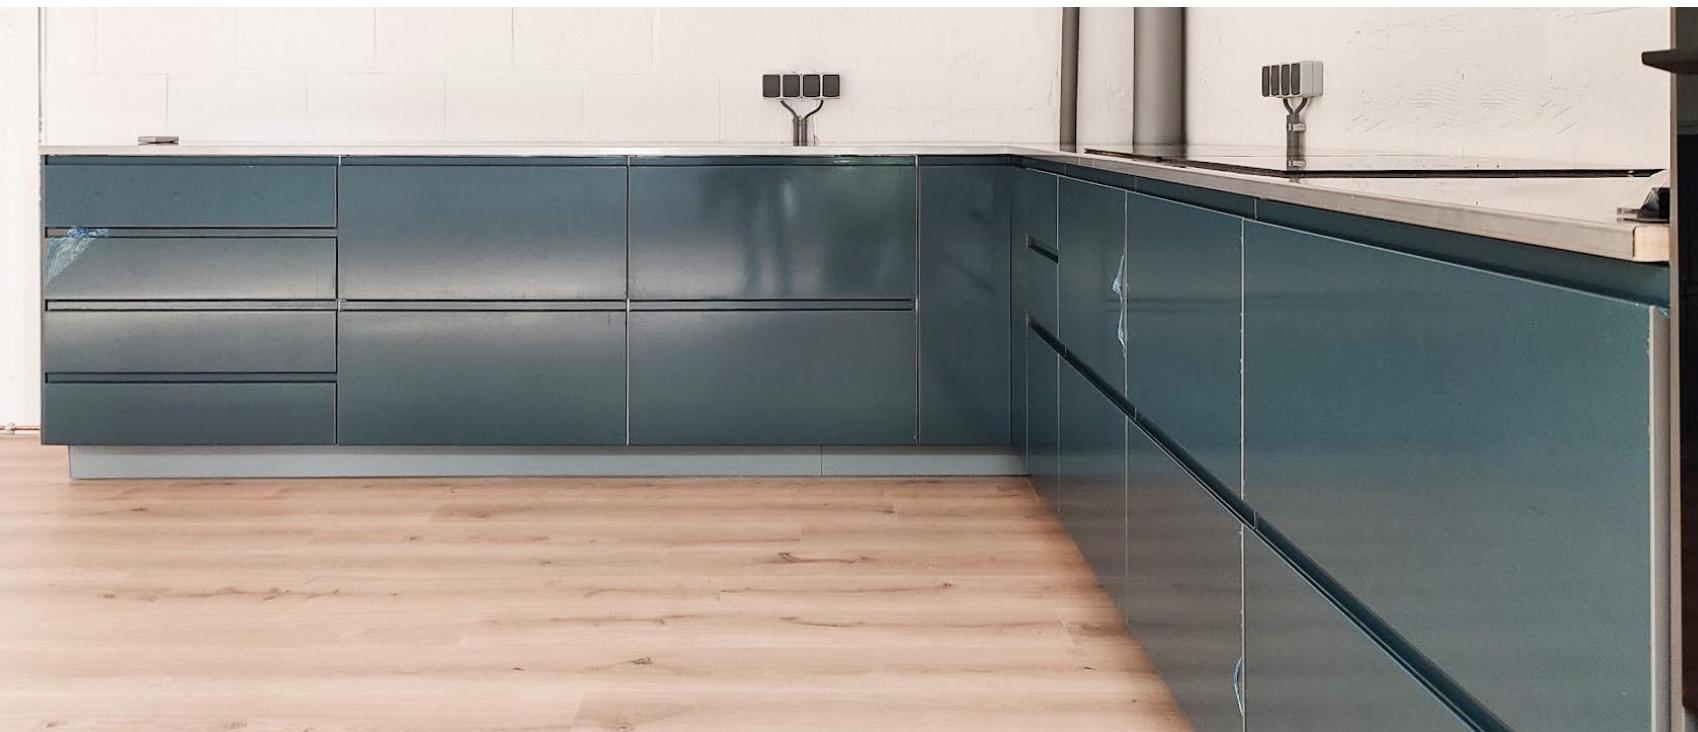
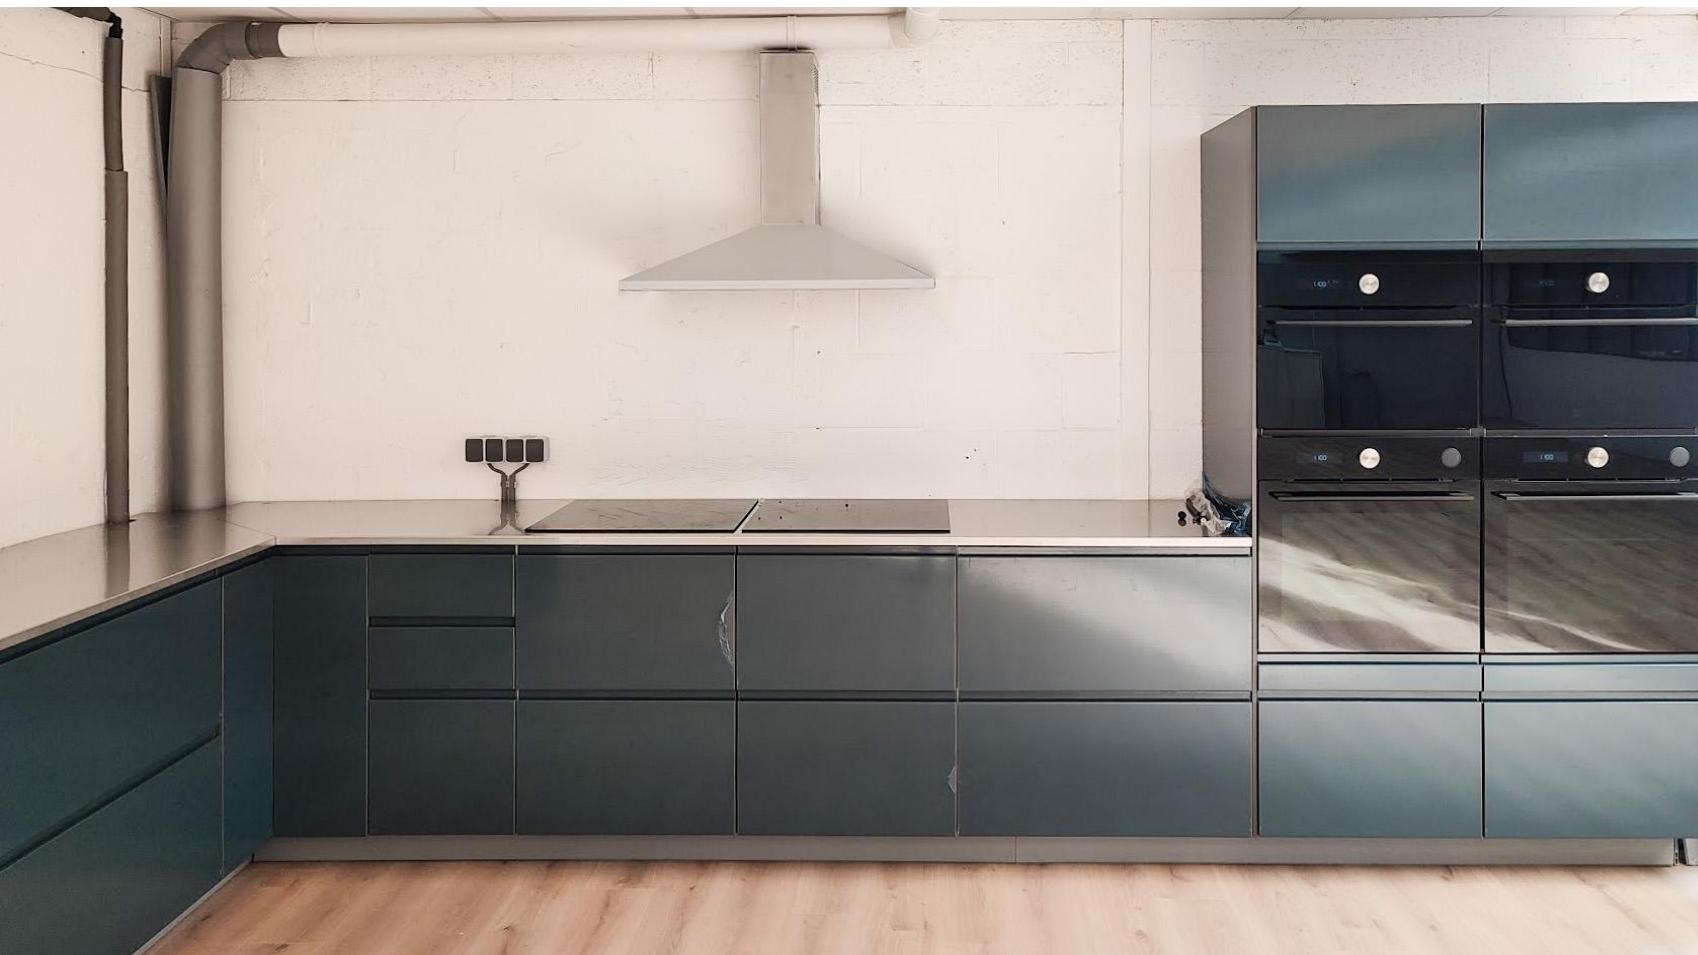
3.21 KITCHEN INSTALLATION Works

Installation of a new IKEA kitchen and kitchen equipment in the canteen that was bought by CEAD.

Make sure that kitchen equipment will work regarding "Electricity use protocol" while it is connected to 60A to avoid overloading. Don't use all kitchen equipment simultaneously.

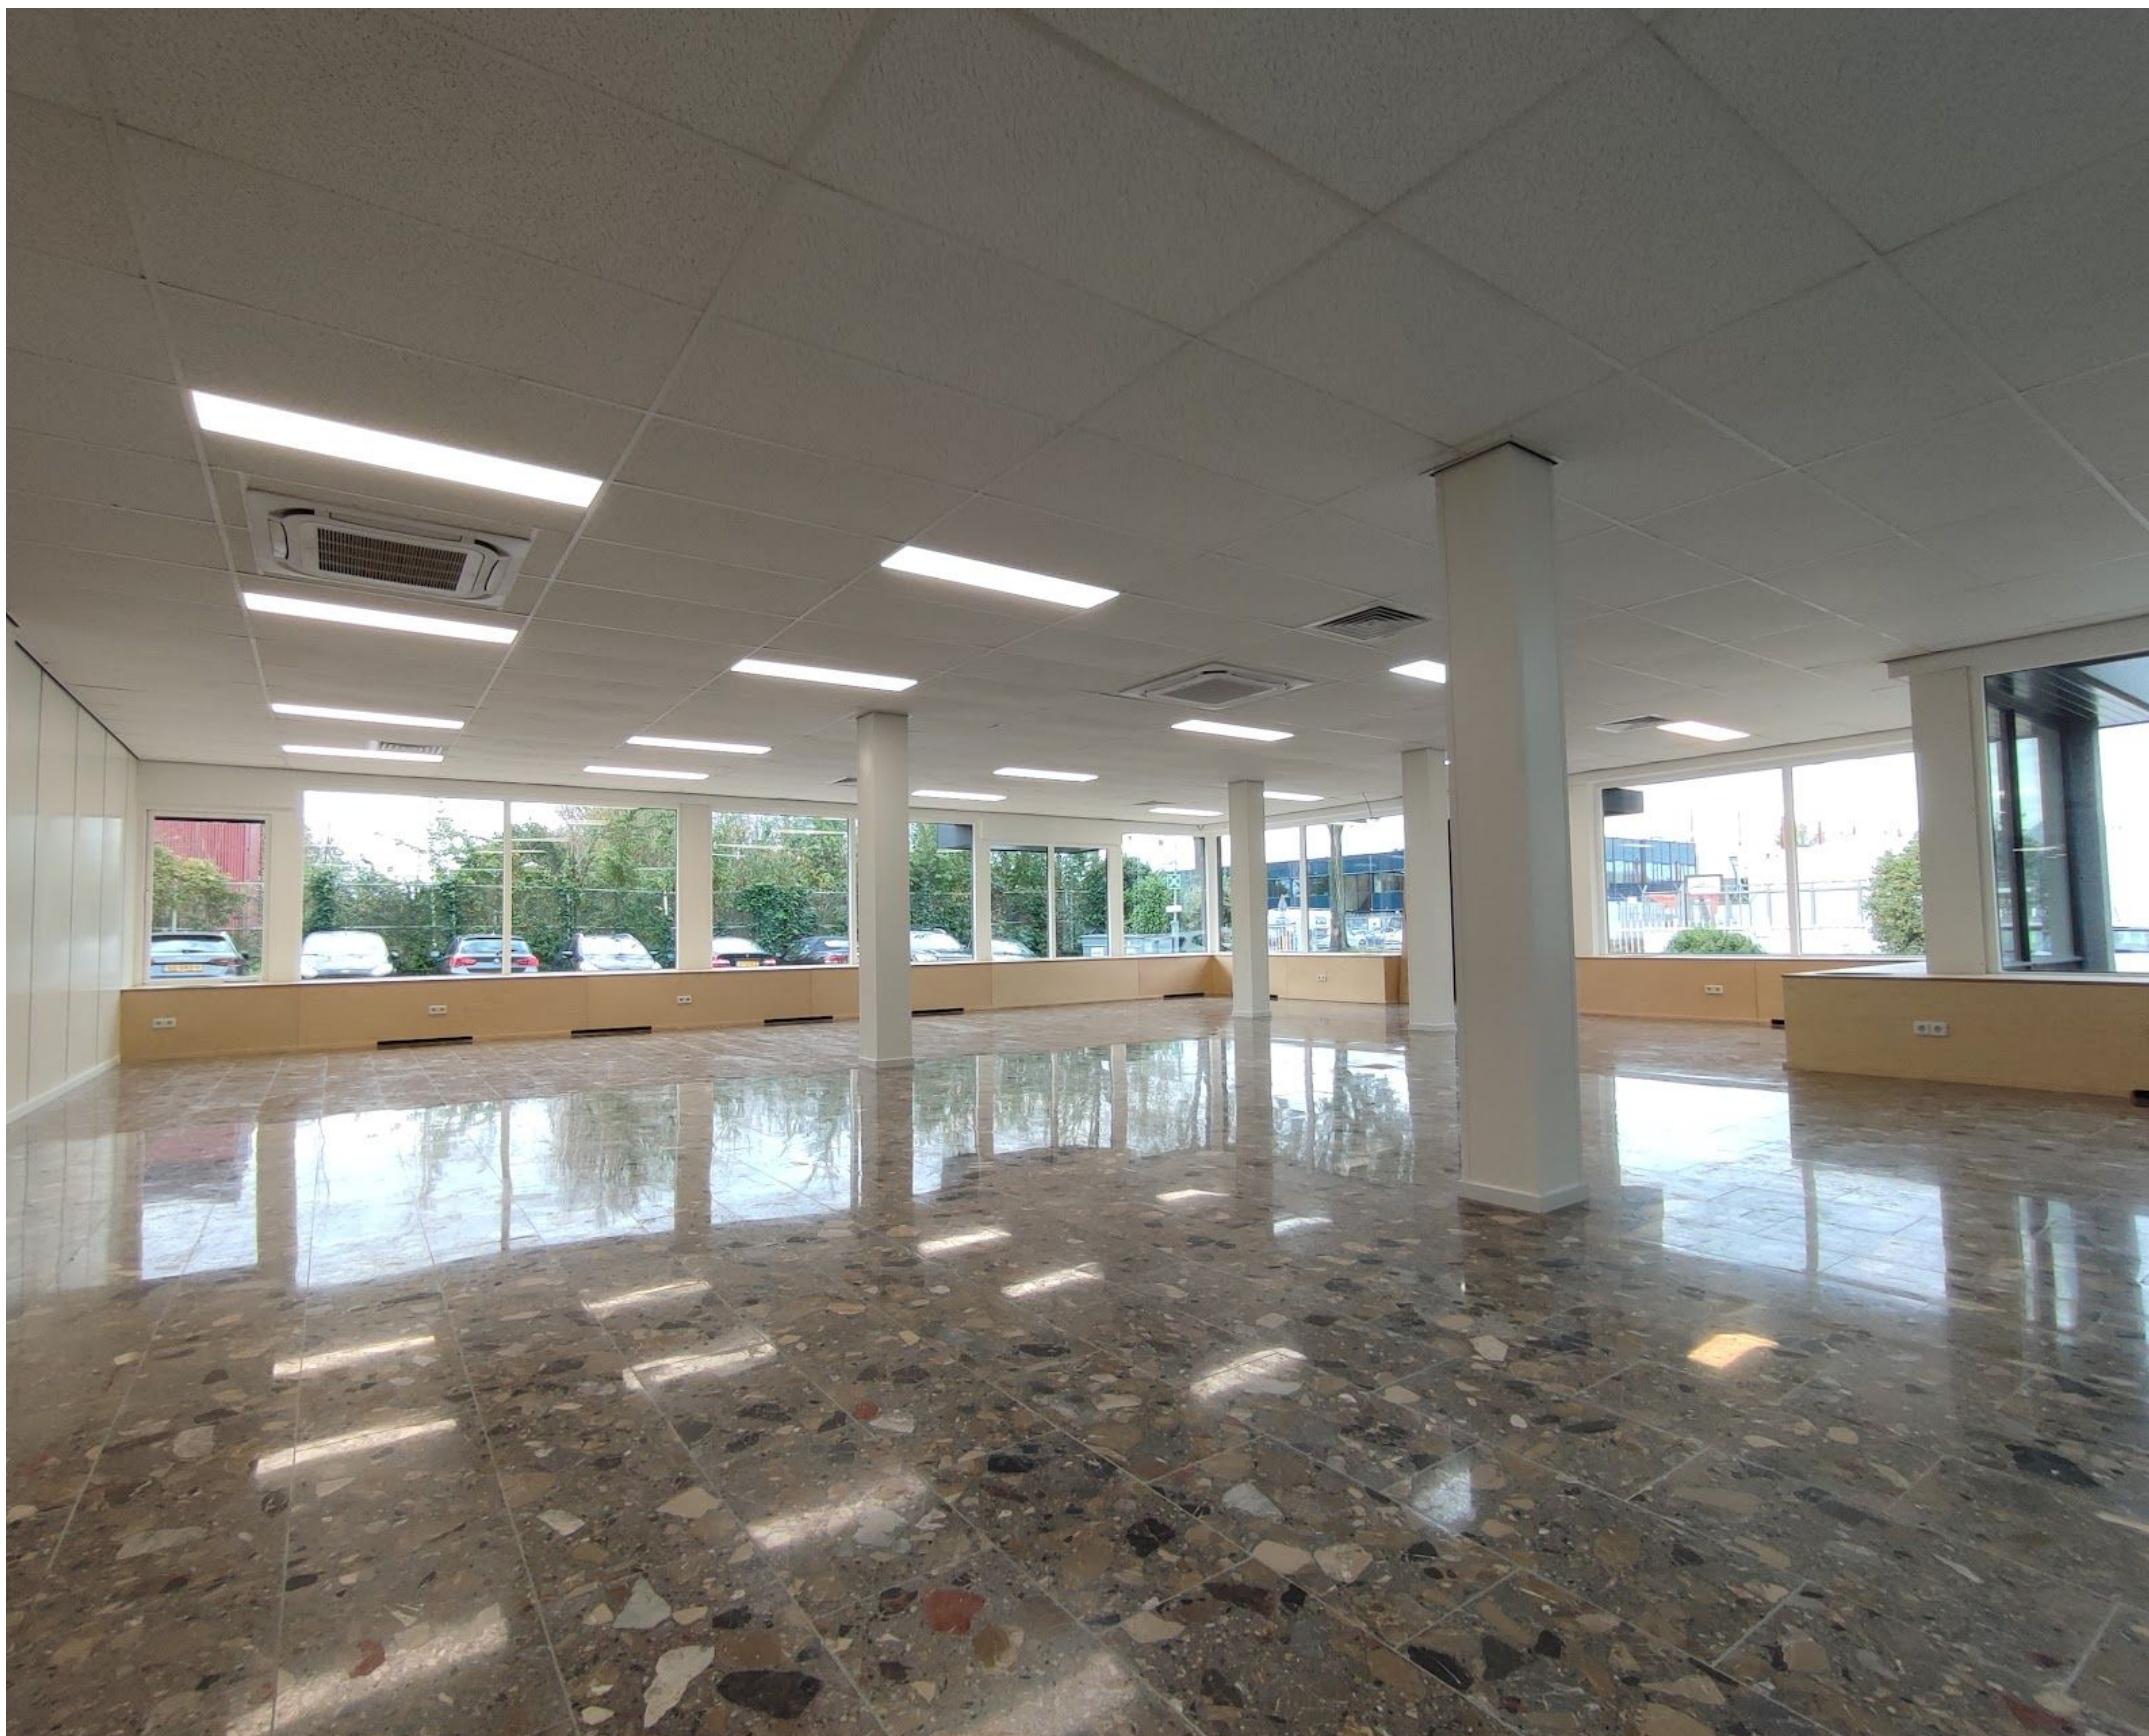
3.22 NEW LED PANELS Office part

Installation of 45 ceiling LED panels in the office

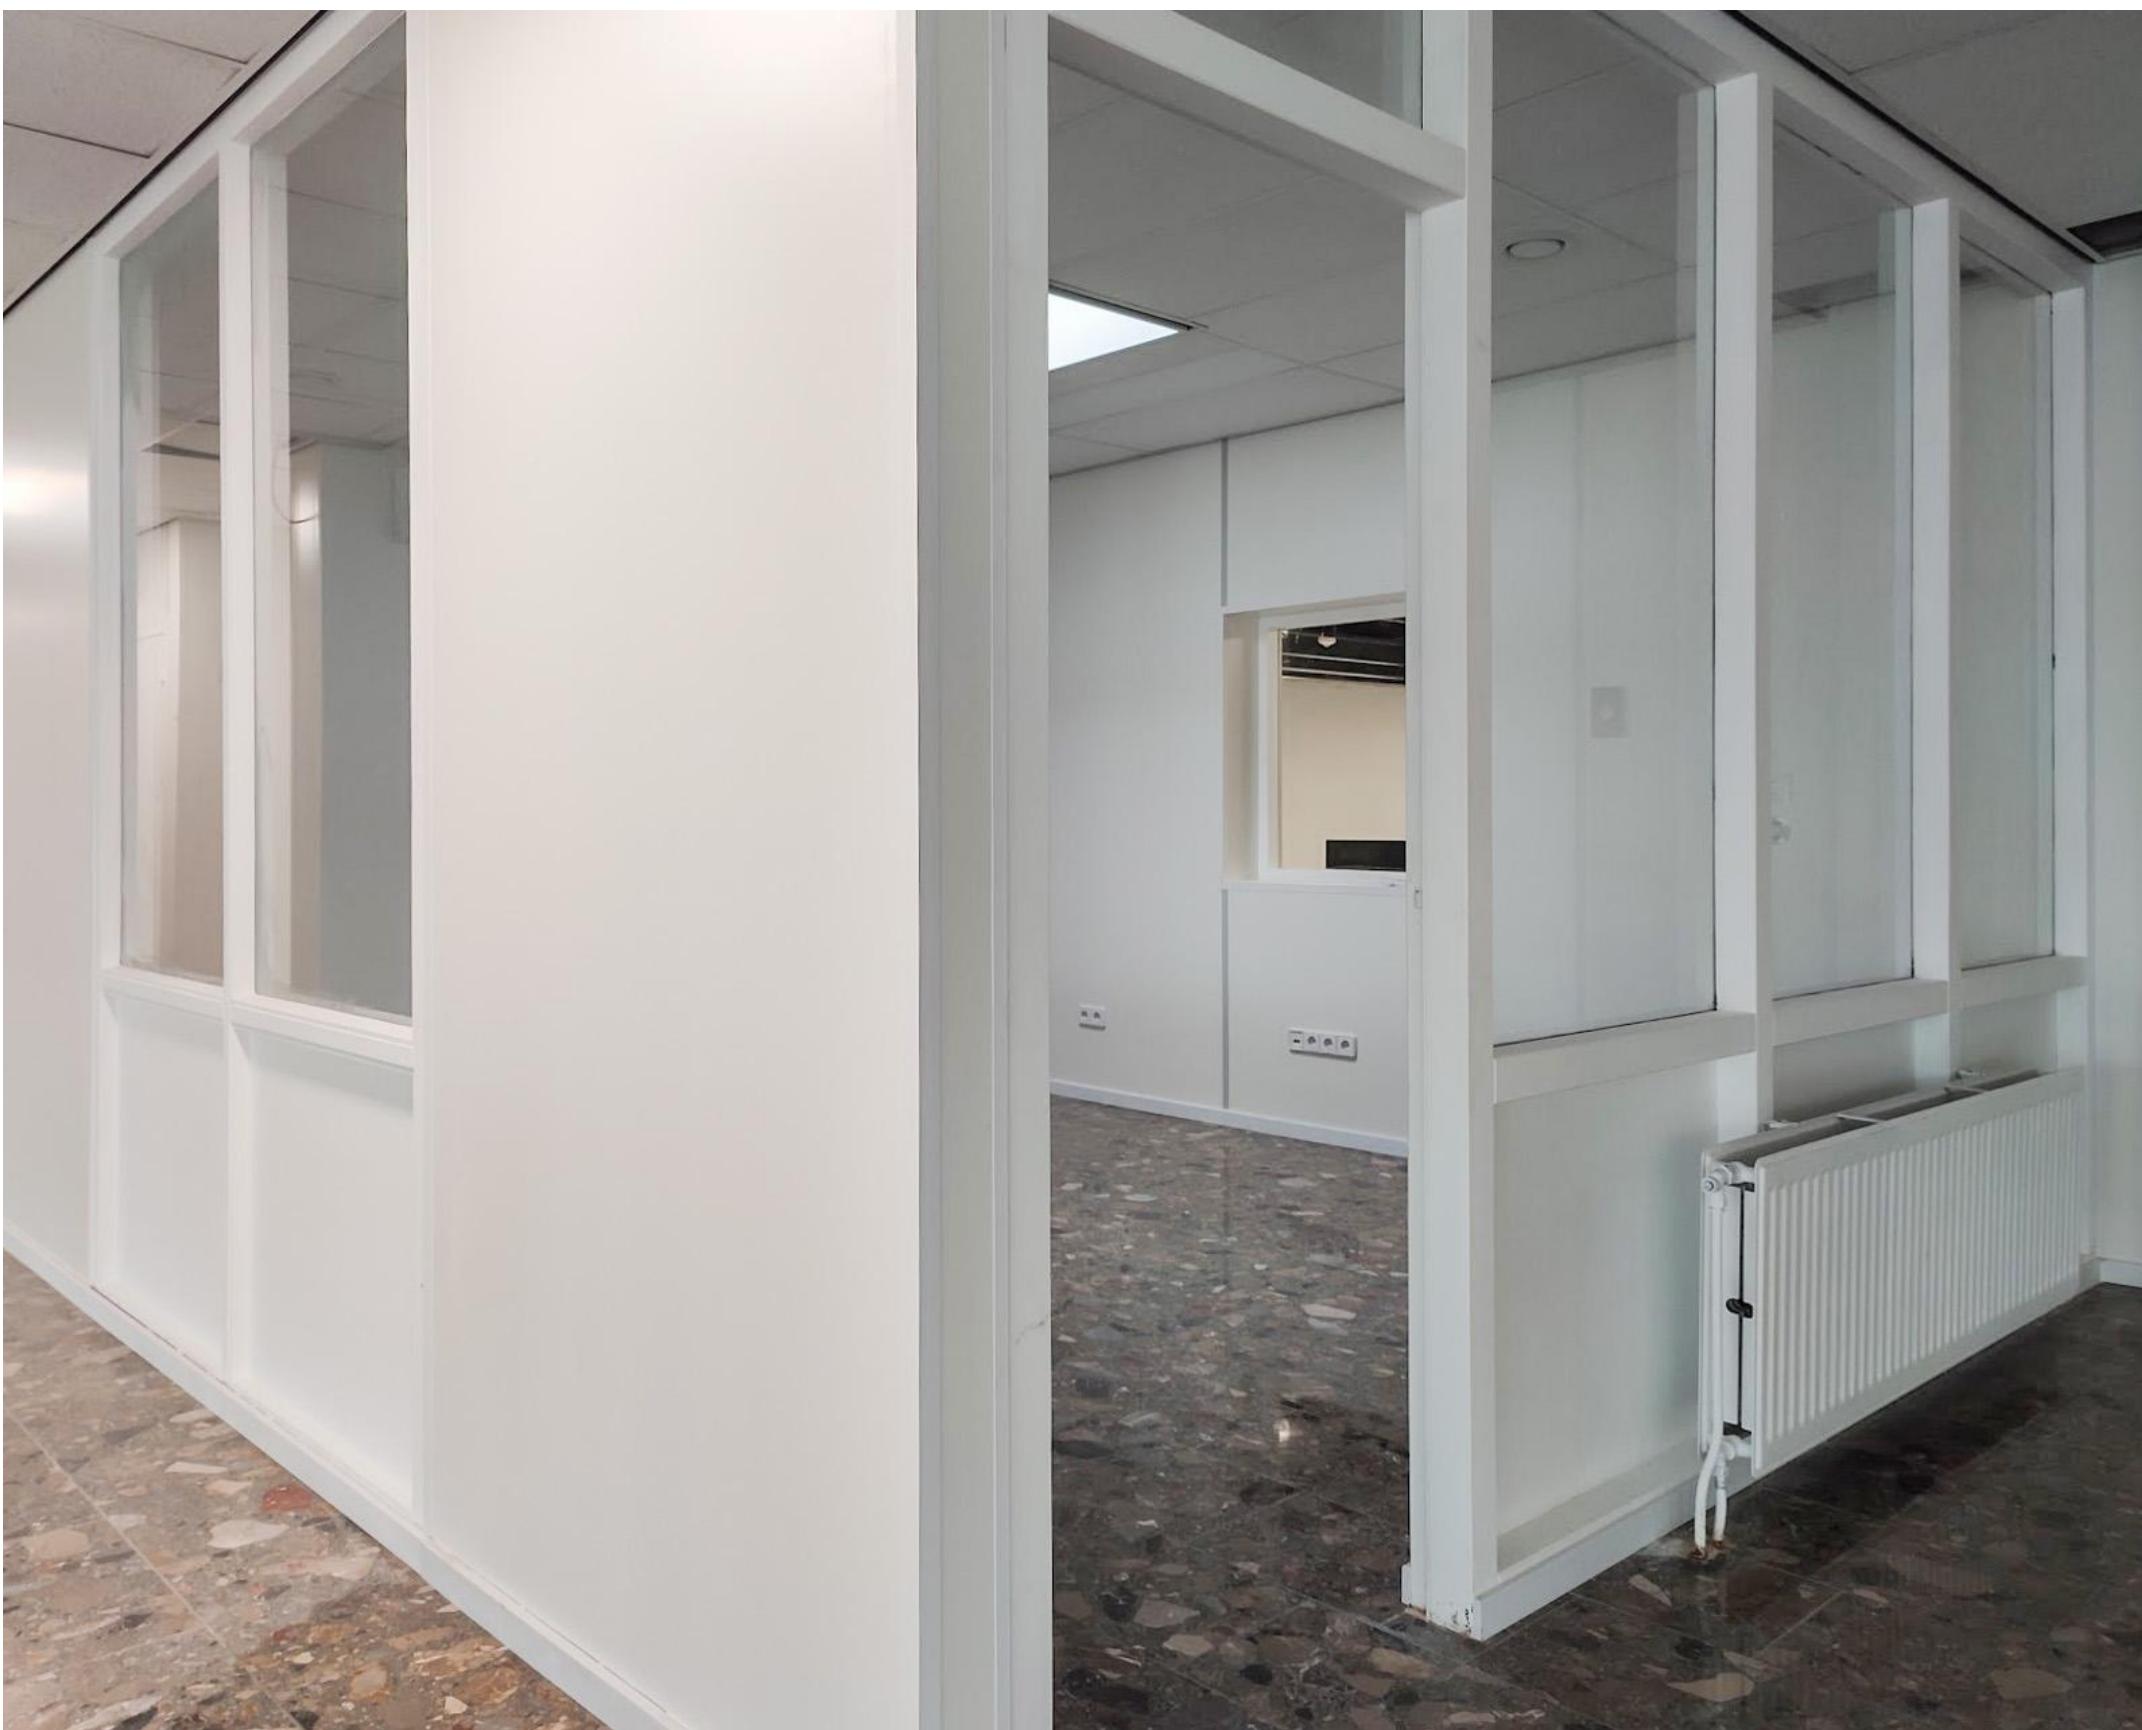
3.23 PAINTING WORKS Interior office parts

Description:
Paintworks in the office and workshop area <ul style="list-style-type: none">• Window paintwork - 178,56 m²• Meeting room carpentry paintworks - 27,7 sq.m• Door paintwork - 20 pieces
Internal maintenance/Repairs/Orders:
none
External maintenance/Warranty:
none
Links to files:
none
Specific alerts/warnings/remarks:
none
